REPORT

**Water Infrastructure
Master Plan**

City of Bloomington, IL

November 2019

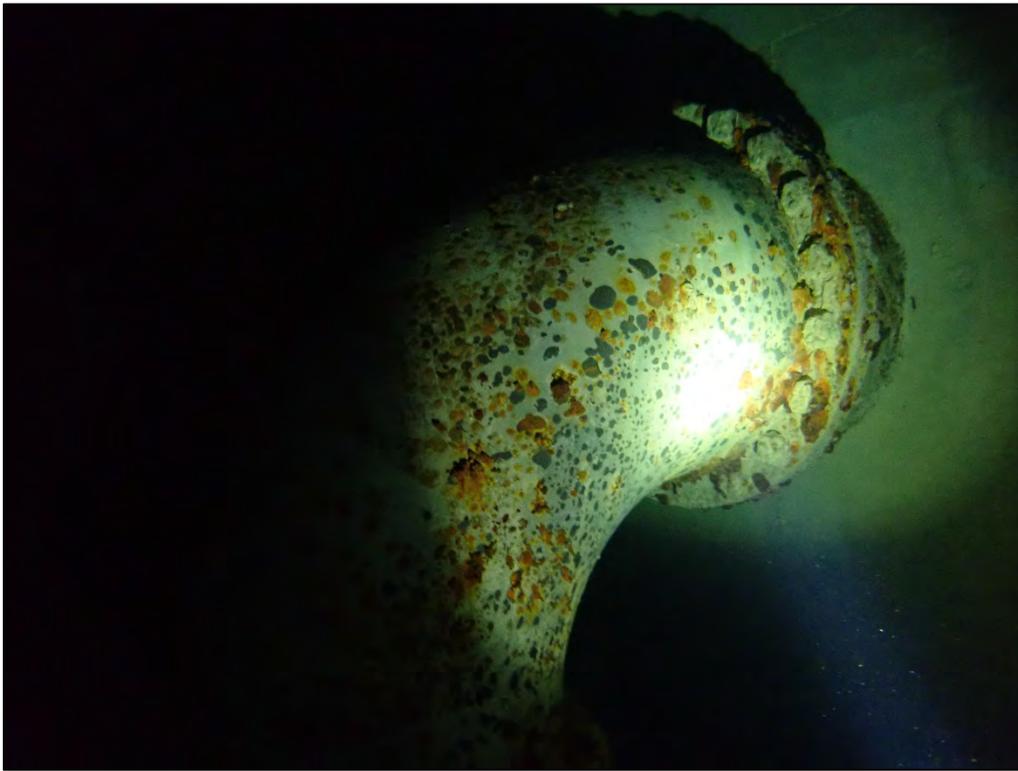
Photograph 3: Typical condition of influent pipe at west wall.

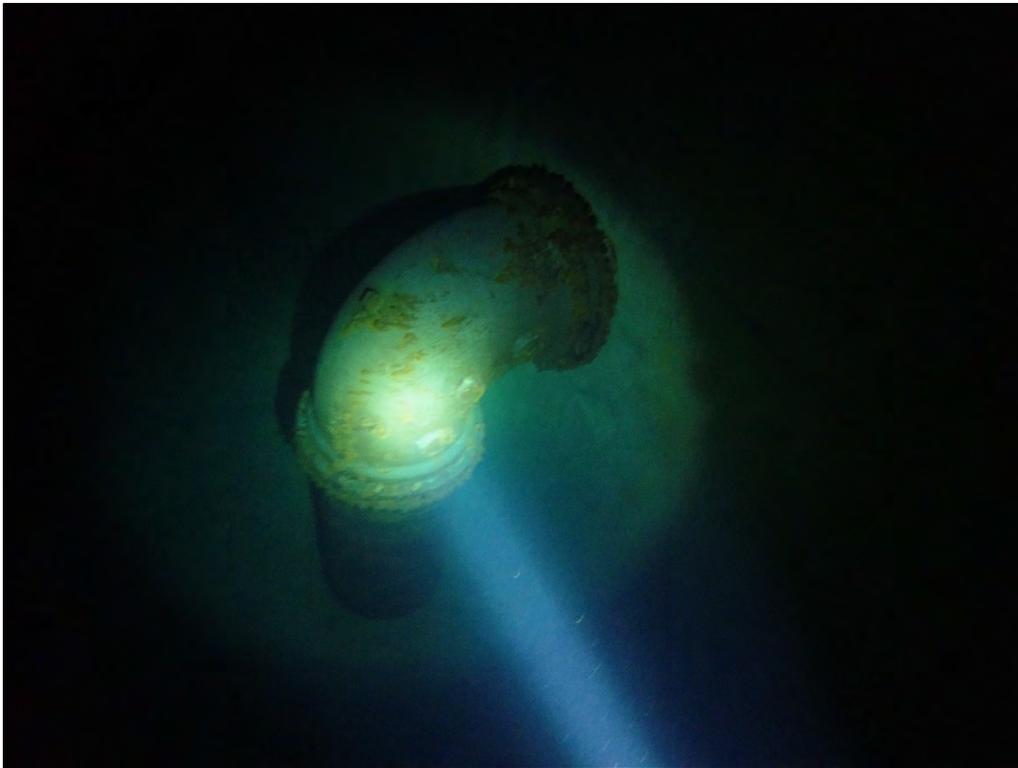
Photograph 4: Typical condition of transfer pipe at south wall.

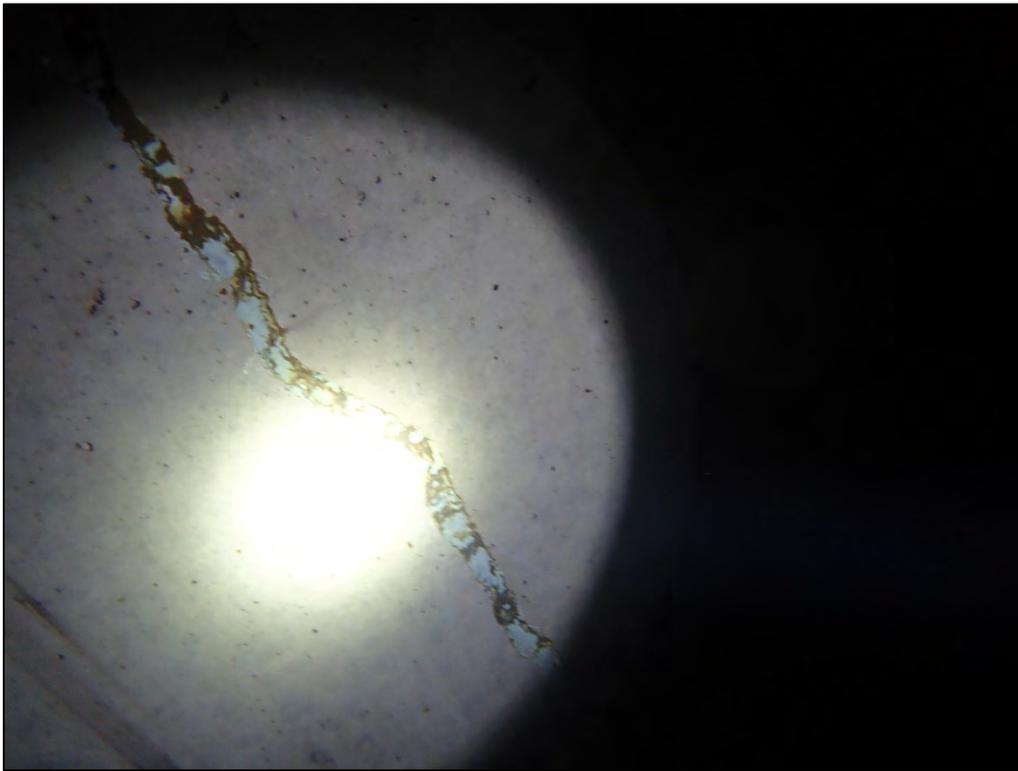
Photograph 5: View of typical patched vertical wall crack.

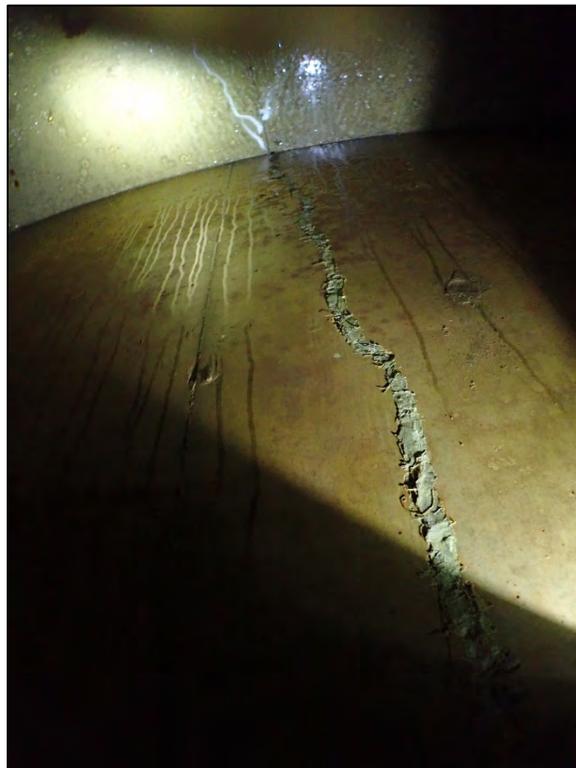
Photograph 6: View of typical patched vertical wall crack.

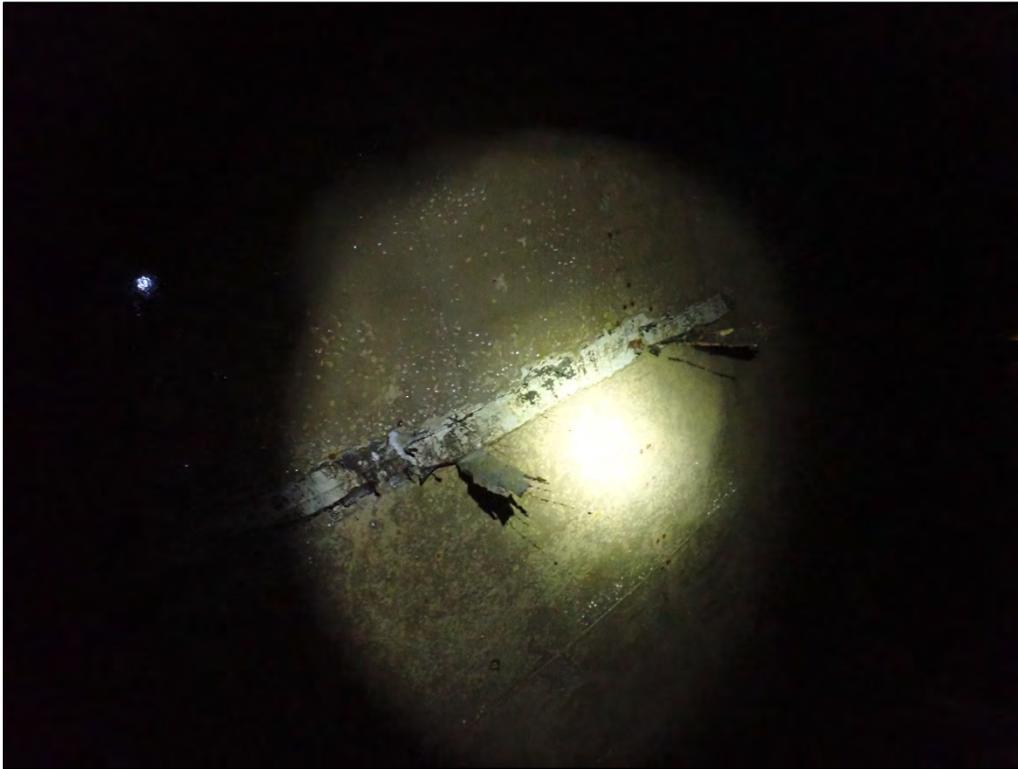
Photograph 7: View of deteriorated underdeck joint seal.

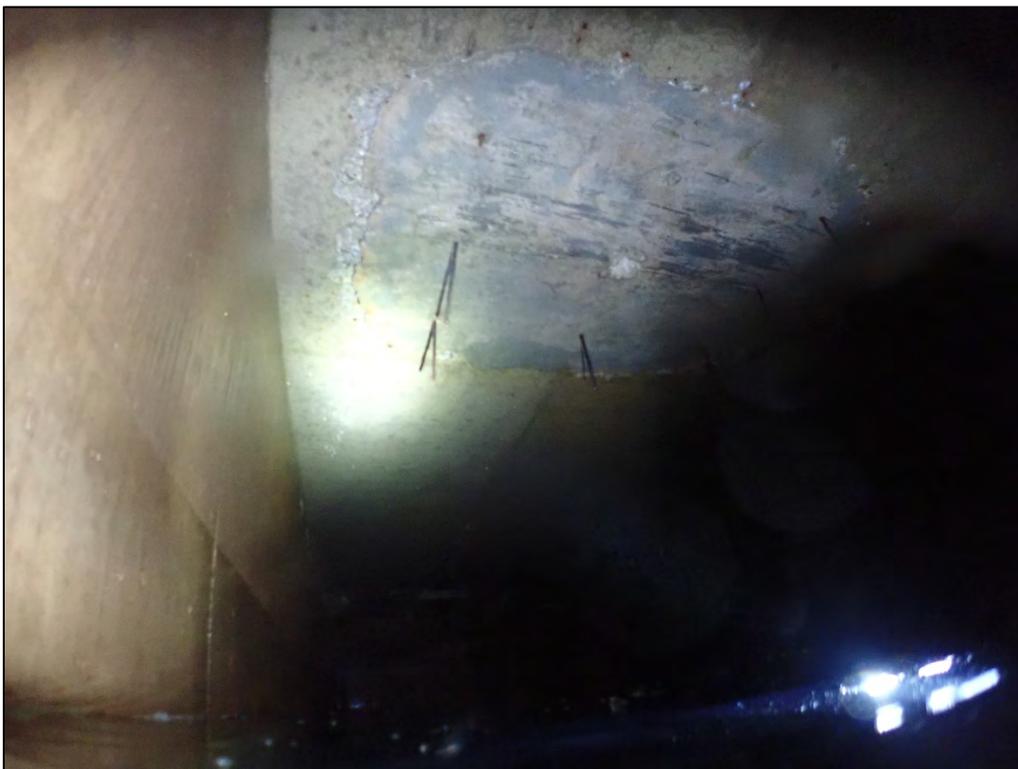
Photograph 8: View of the underdeck patch between Columns C-9 and D-9.

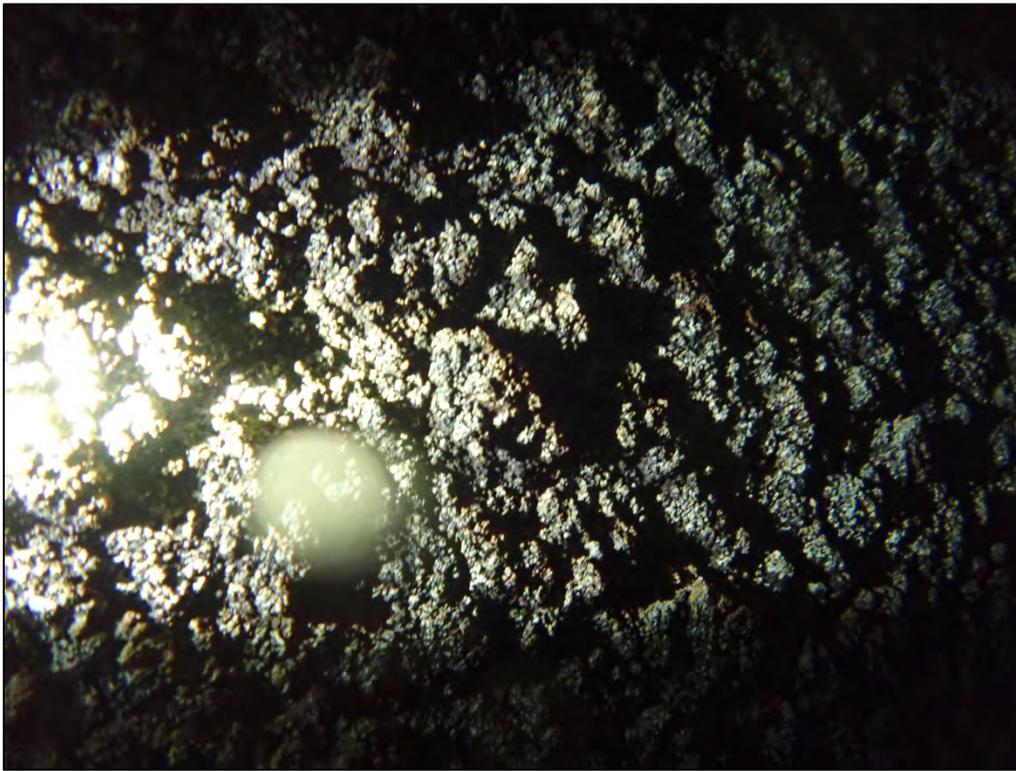
Photograph 3: Typical texture and condition of coating material on wall.

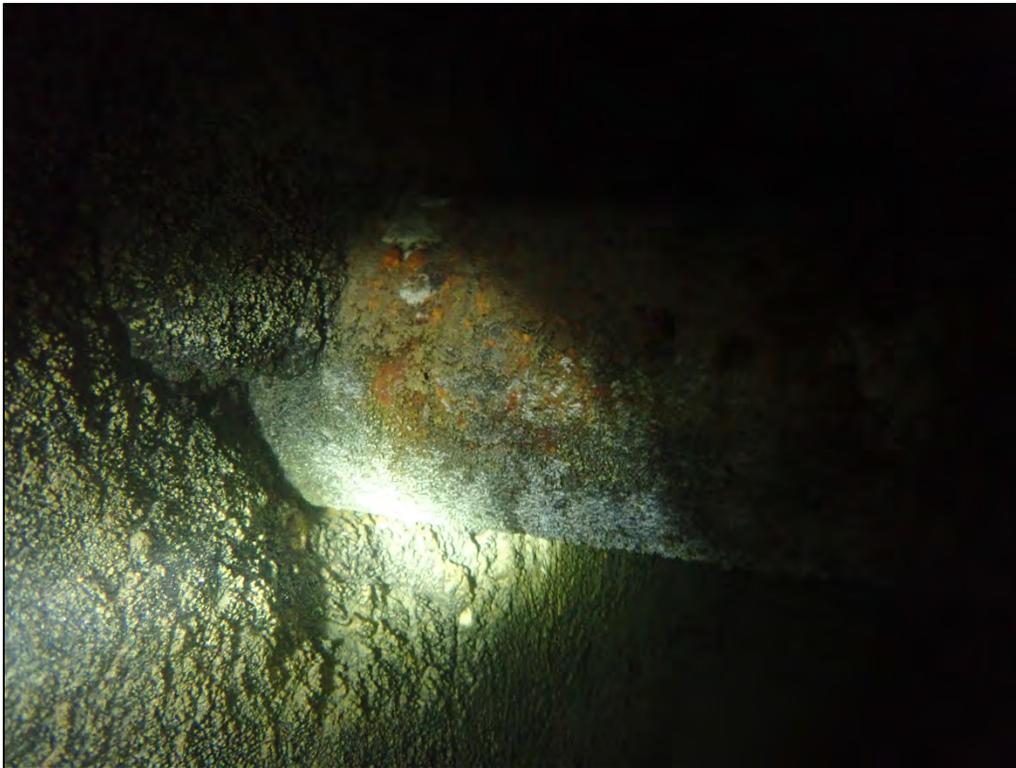
Photograph 4: Concrete section loss around bottom of suction pipe.

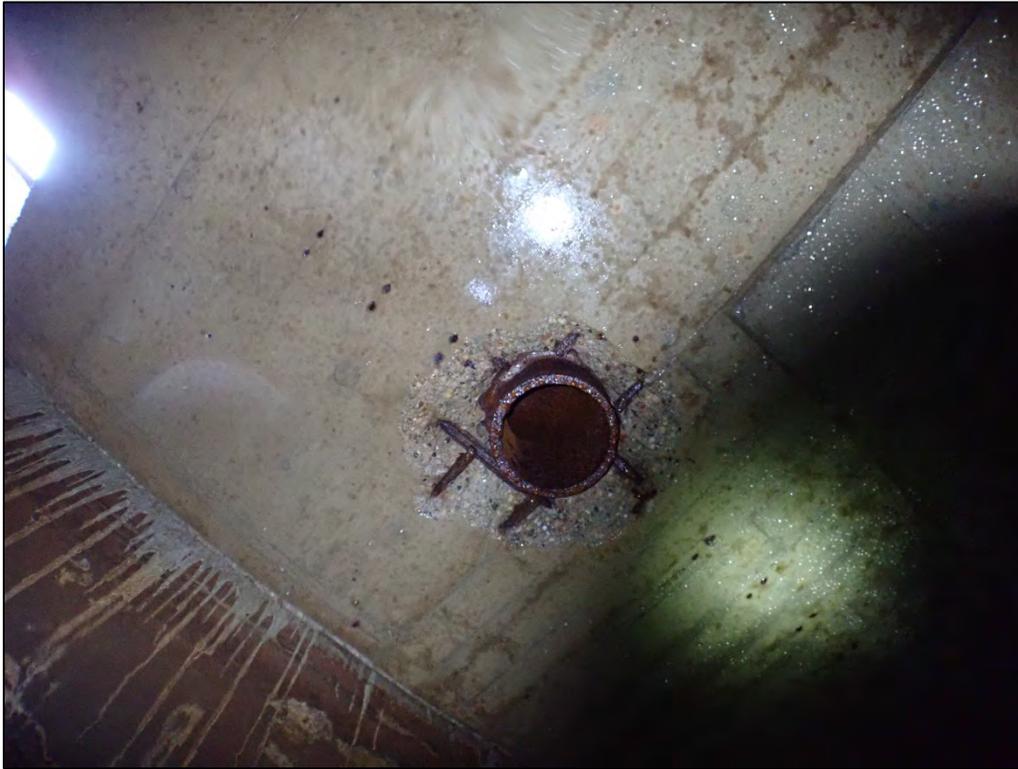
Photograph 5: Spall with corroded reinforcing steel at Pipe protrusion in underdeck.

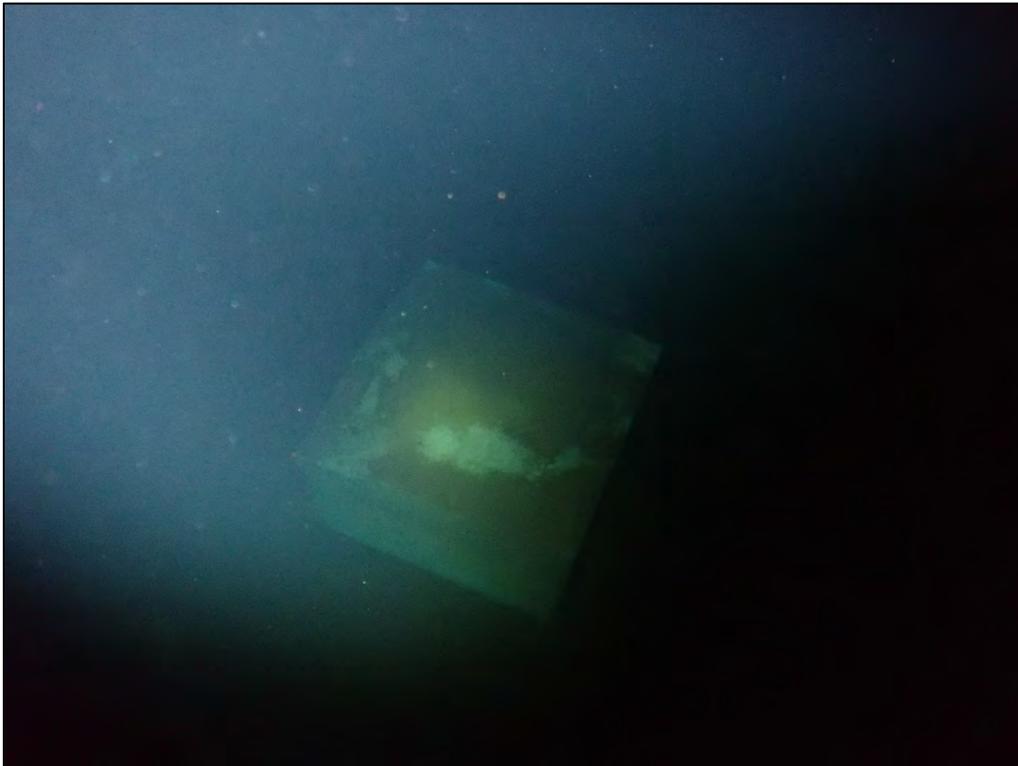
Photograph 6: View of concrete block on floor near center of tank.

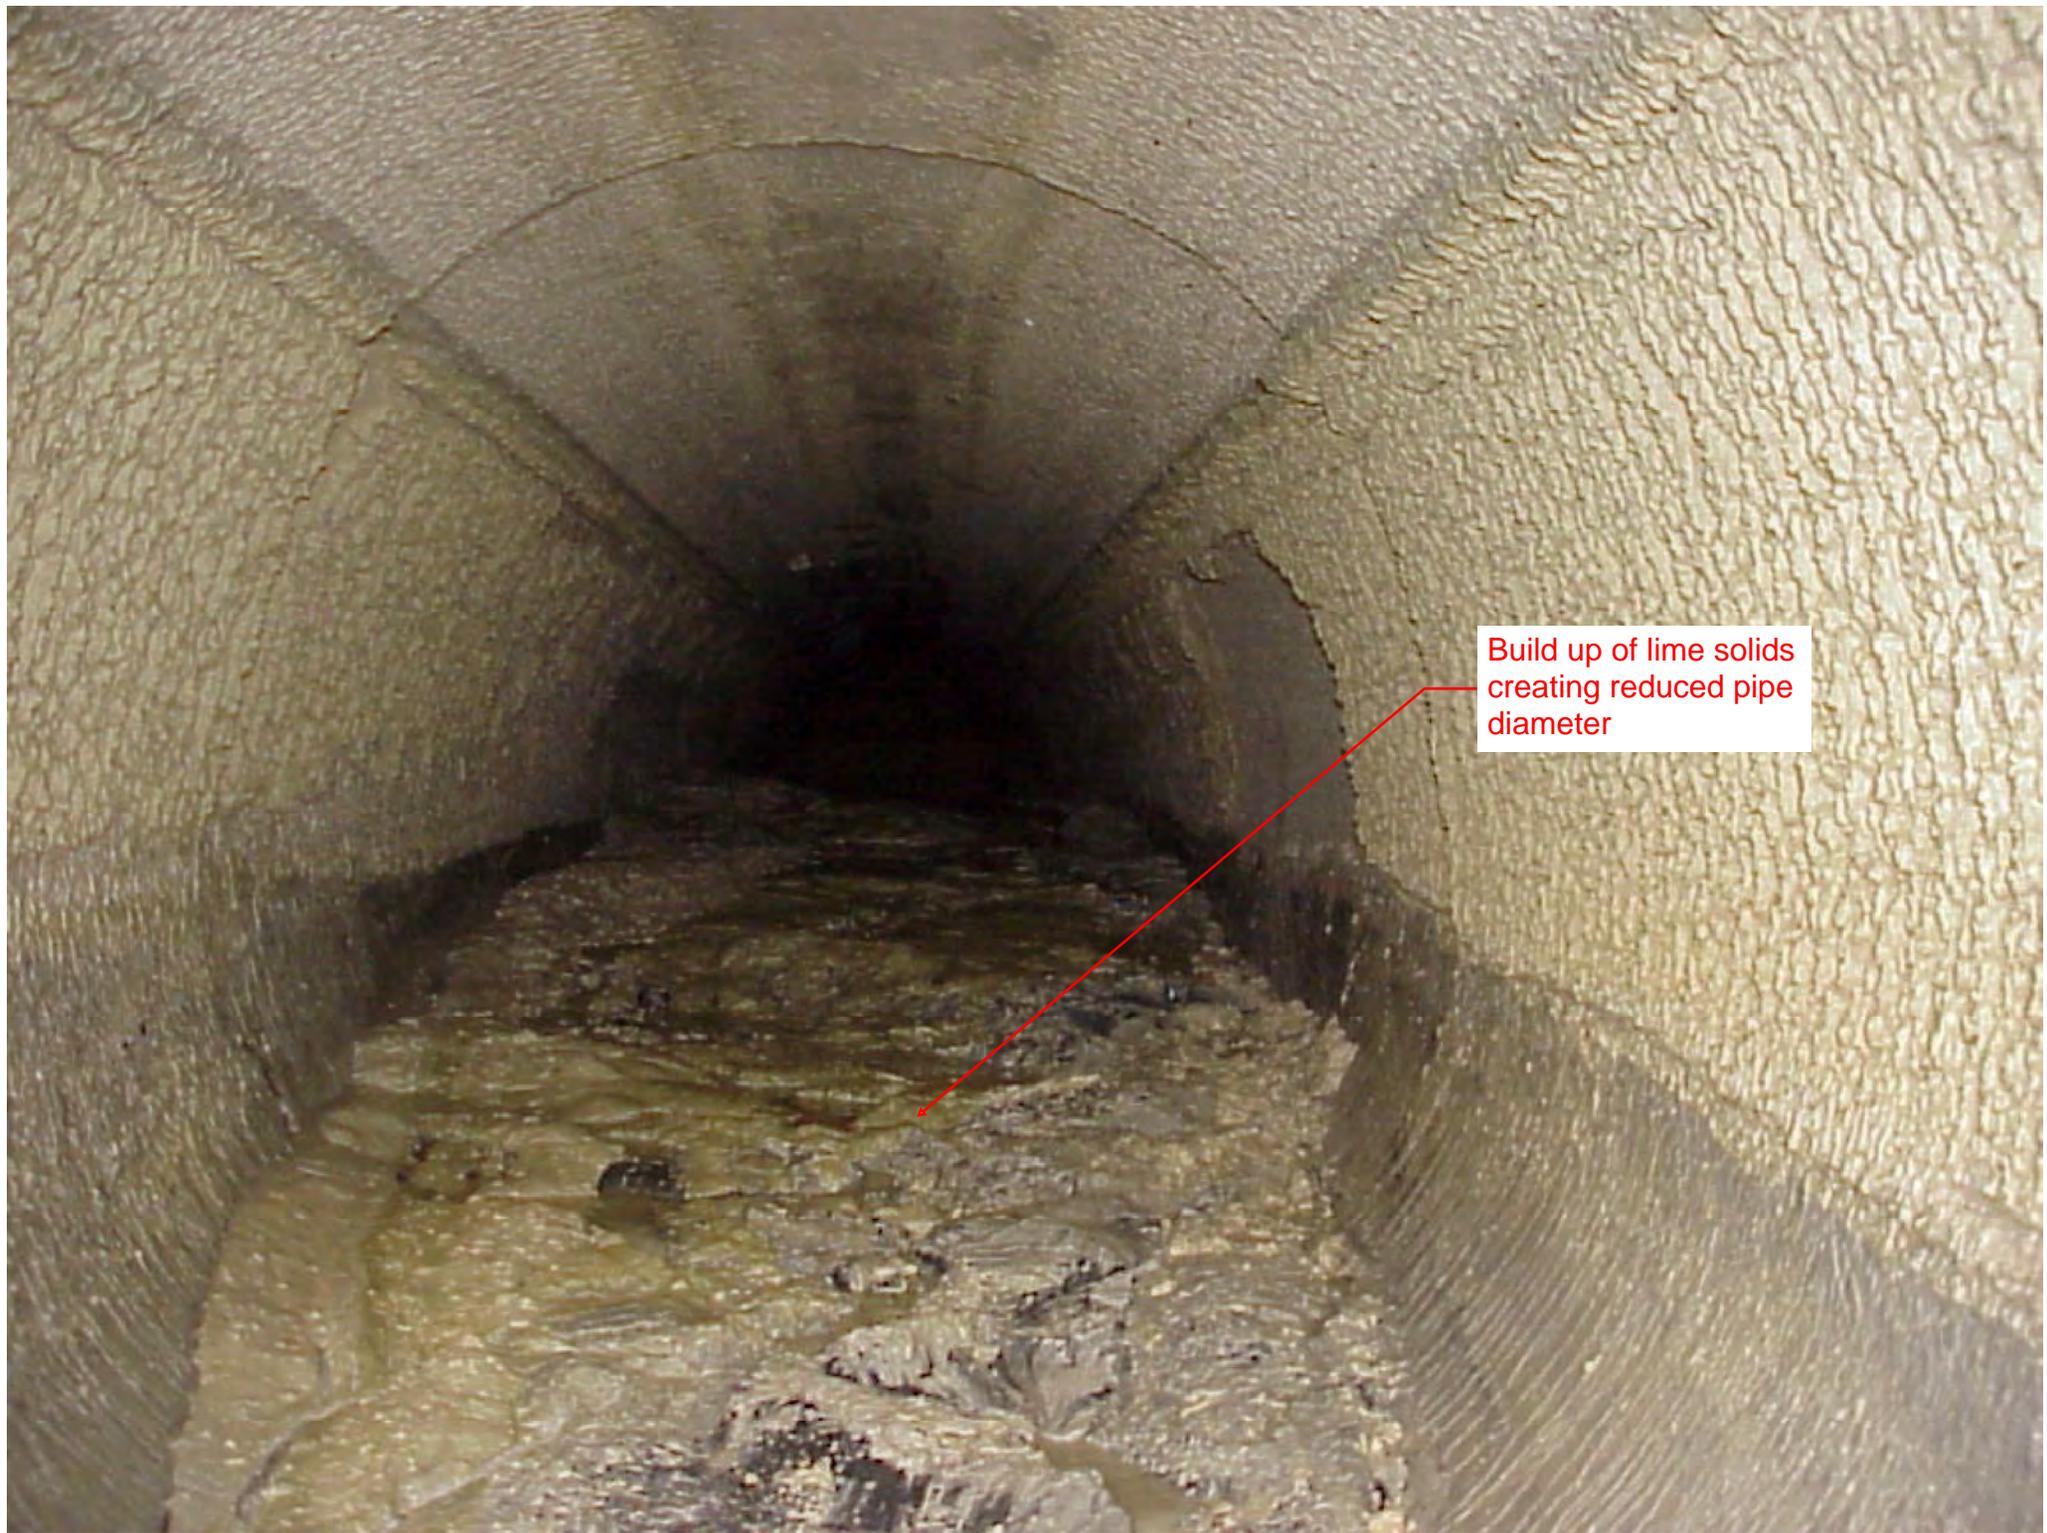
Build up of lime solids
creating reduced pipe
diameter

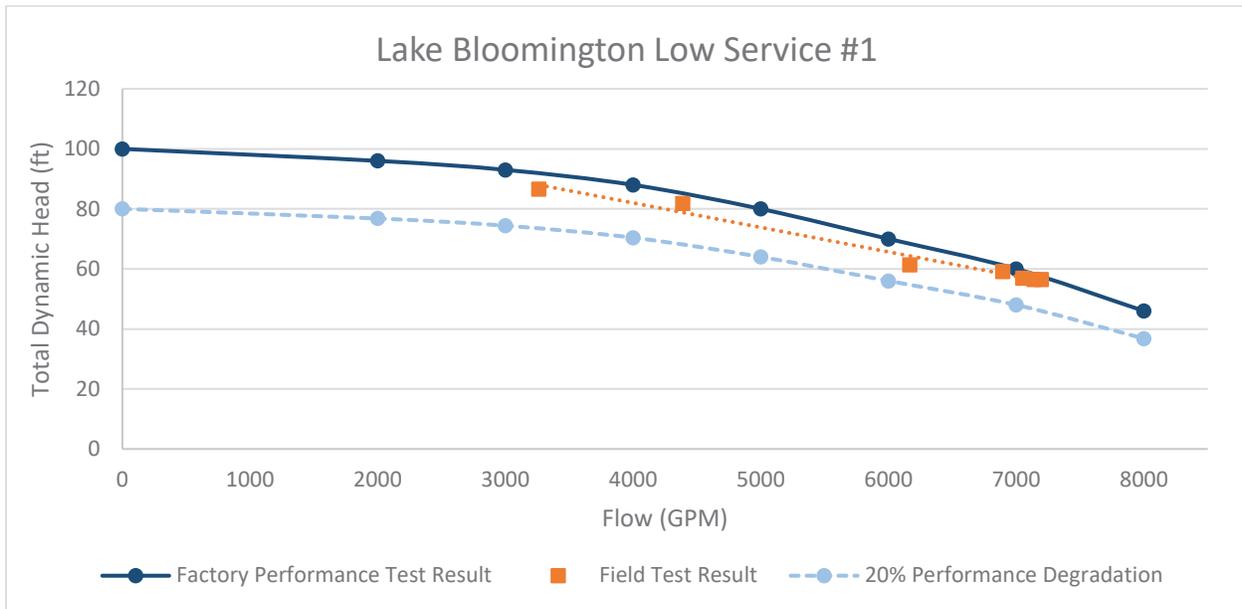
Figure 2: Original and updated performance curves for Lake Bloomington Low Service Pump #1. Complete results of the factory performance tests are shown in Figure H2-1.

As shown in Figure 3, Pump #3 test results show a greater degradation in performance compared to Pump #1. The TDH has dropped by 6% to 12% from the factory testing results. Lower flow rates of 3,000 gpm to 4,000 gpm experienced a lesser drop in performance than higher flow rates of around 8,000 gpm. However, the test results for Pump #3 are skewed due to the location used for measuring the suction head. There was no available pressure tap directly on the suction end of Pump #3, and the suction head was measured from the Pump #1 suction tap. The test results also show a 20% drop in magnitude of efficiency at low flow rates. The difference in efficiency from the original curve is gradually reduced as the flow rate increases. At around 7,500 gpm, the pump started to operate at an improved efficiency from when it was originally installed. Polynomial regression indicates that the optimal flow rate for Pump #3 is around 8,000 gpm.

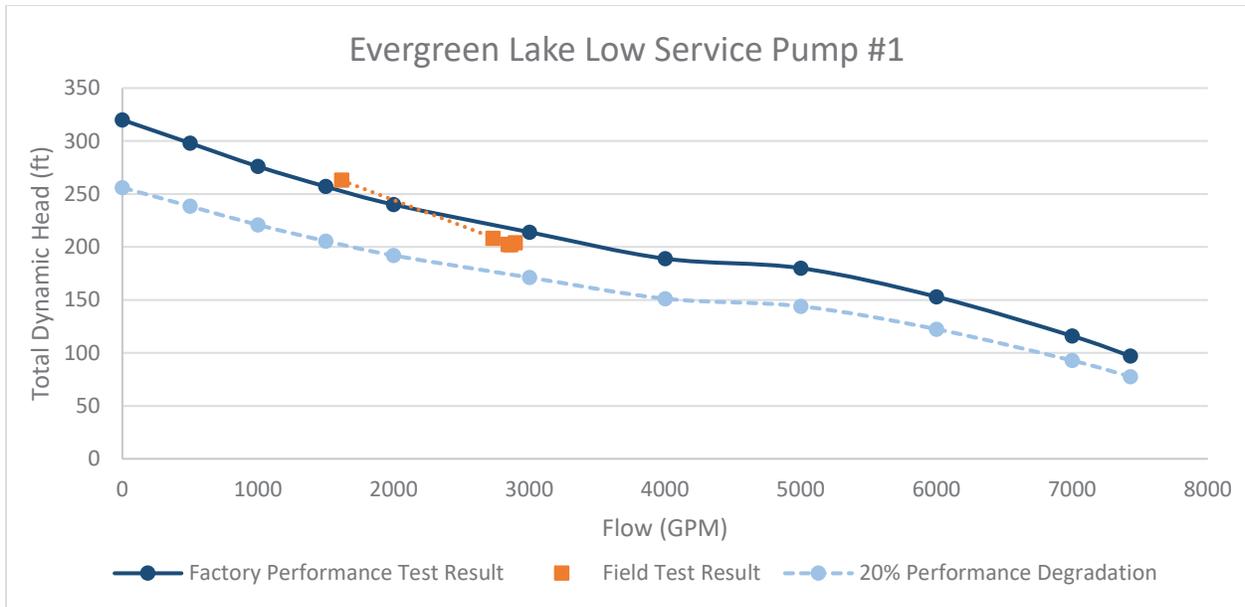
Figure 4: Original and updated performance curves for Evergreen Lake Low Service Pump #1. Complete results of the factory performance tests are shown in Figure H2-3.

Figures 4, 5, and 6 show the results of the performance tests conducted on the Evergreen Lake Low Service Pumps on February 14, 2018. All three of the Evergreen Lake Low Service pumps were tested. Closing the discharge control valve did not significantly impact flow rate while testing Pumps #1 and #3, causing the data to cluster together. Because the data was clustered together, performance was only measured over a narrow range of flow conditions for Pumps #1 and #3. The change in Pump #1 performance is negligible. Pump #1 performance has slightly improved at flow rates around 1,600 gpm and slightly decreased at higher flow rates around 2,500 to 3,000 gpm since the original test was conducted. On the other hand, the performance of Pumps #2 and #3 shows a larger degradation to around 80% of their factory performance baseline since they were installed. Pump #2's TDH at flow rates around 2,500 gpm has dropped below 80% of the TDH recorded during factory testing.

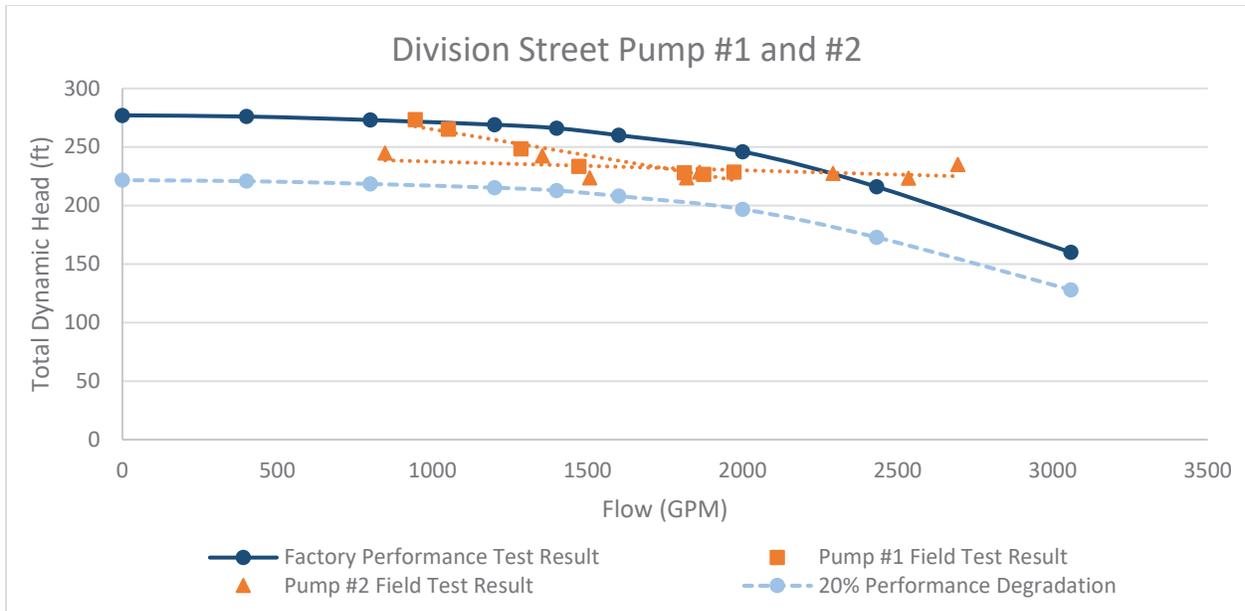
Figure 10: Original and updated performance curves for Division Street Pump Station Pump #1. Complete results of the factory performance tests are shown in Figure H2-9.

Figures 10 and 11 show the results of the performance tests conducted at the Division Street Pump Station on February 12, 2018. Only Pump #1, #2, and #3 were tested because there were mechanical issues in turning on Pump #4. In addition, the pitot data collected while testing Pump #1, #2, and #3 yielded an uneven velocity profile. The velocity profile indicated a turbulent flow condition at the location of the pitot rod, which could have been caused by a partially closed valve upstream of the pitot tap. As a result, the pitot data was deemed unreliable so the flow readings from the local flow meter were used in its place. The local flow meter's accuracy is unknown. Pumps #1 and #2 have the same factory performance curve and their results are presented together in Figure 10. Pumps #1 and #2 performance has degraded by around 5% to 10% since their original factory test. Pump #1 performance has been reduced the most at flow rates between approximately 1,300 gpm and 2,000 gpm, while Pump #2 experienced the largest reduction in performance at flow rates between 800 gpm and 1,800 gpm. Pump #3 exhibited no performance degradation. None of the data points for any pump show a performance decrease greater than 20%.

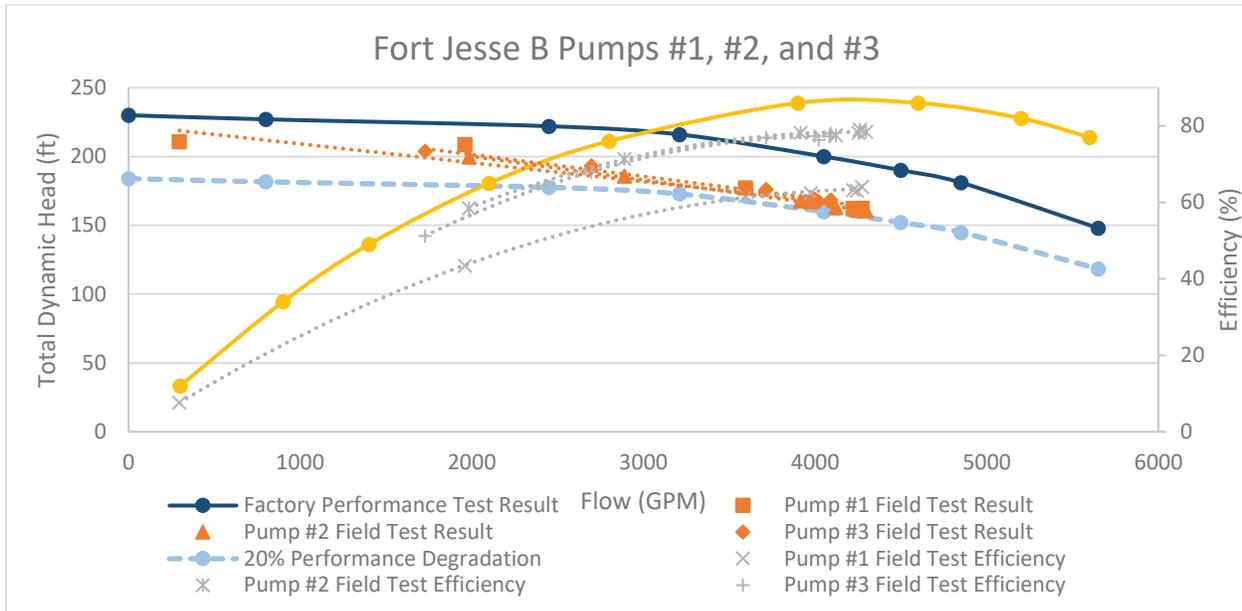
Figure 13: Original and updated performance and efficiency curves for Fort Jesse B Pump Station Pump #1. Complete results of the factory performance tests are shown in Figure H2-12.

The pumps also have decreased in efficiency since when compared to the factory performance test. The difference in efficiency between the field testing and factory testing is lesser in the lower flow rate tested but increases to 8% to 25% in magnitude at the high-end of tested flow rates. Polynomial regression of the updated efficiency results estimates the optimal flow rate for Pumps #1, #2, and #3 to be 4,400 gpm, 4,200 gpm, and 4,200 gpm respectively.
