REPORT

**Water Infrastructure
Master Plan**

City of Bloomington, IL

November 2019

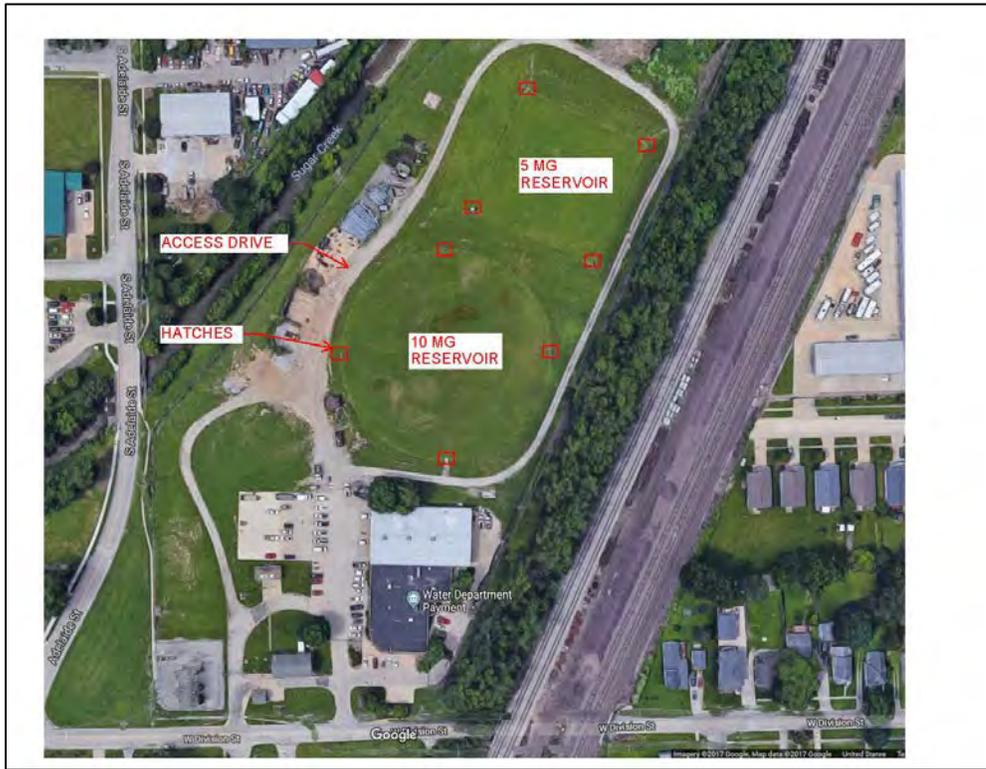
Photograph 1: Overall view of site, looking down.

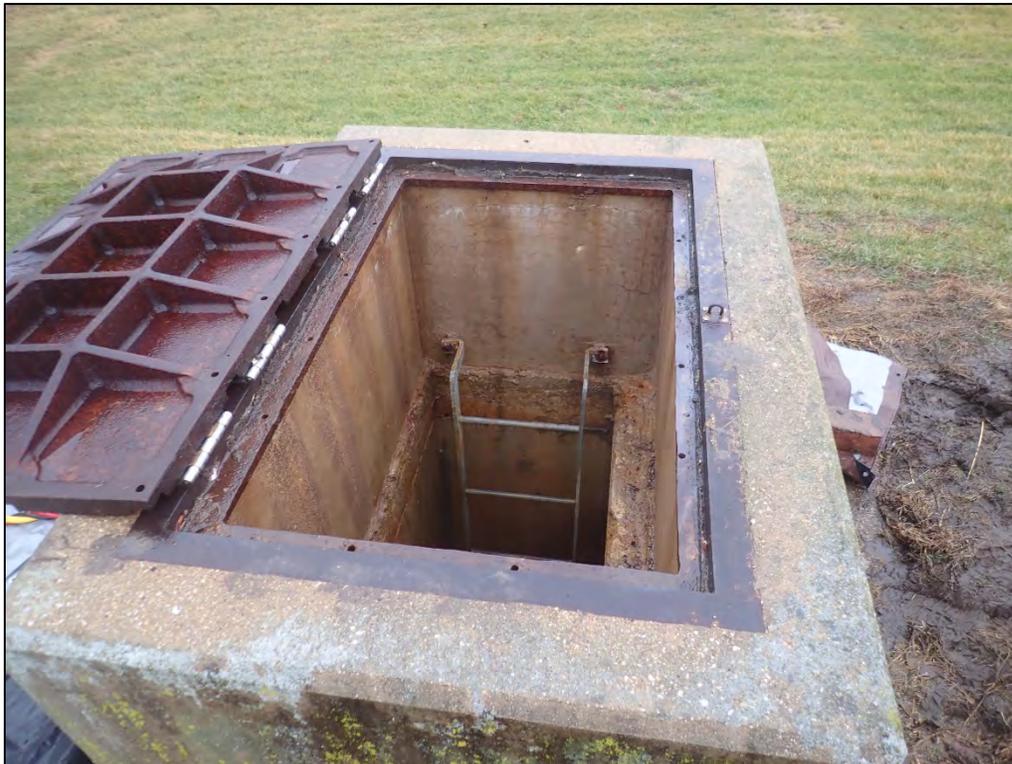
- Exterior
 - Roof access hatches were located at the southeast, northeast, and northwest corners of the tank. The hatches did not have a seal or gasket in place. See Picture 2.

Photograph 2: Typical access hatch opening with permanent ladder.

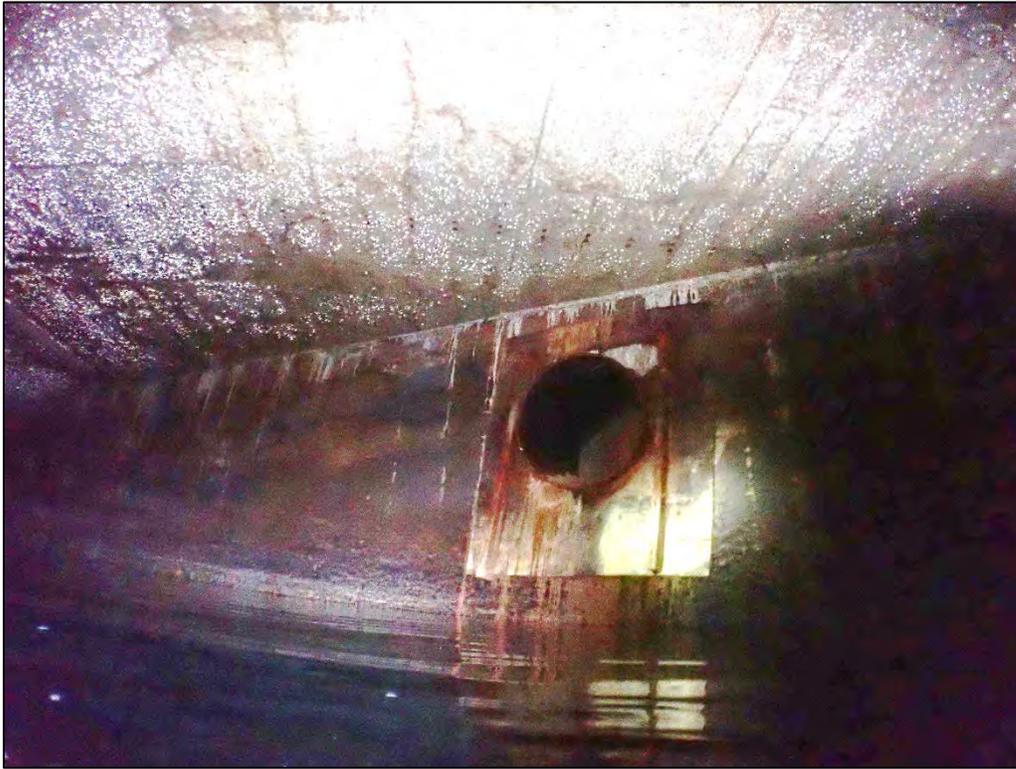
The exposed steel pipe sections in the tank were generally in fair condition with minor corrosion present. The interface between the pipes and floor/walls were sealed with no obvious signs of leakage. Refer to Photographs 7 through 9 for views of the influent pipe, suction pipe, and transfer pipe, respectively.

Photograph 7: View of suction pipe located 2 ft above waterline.

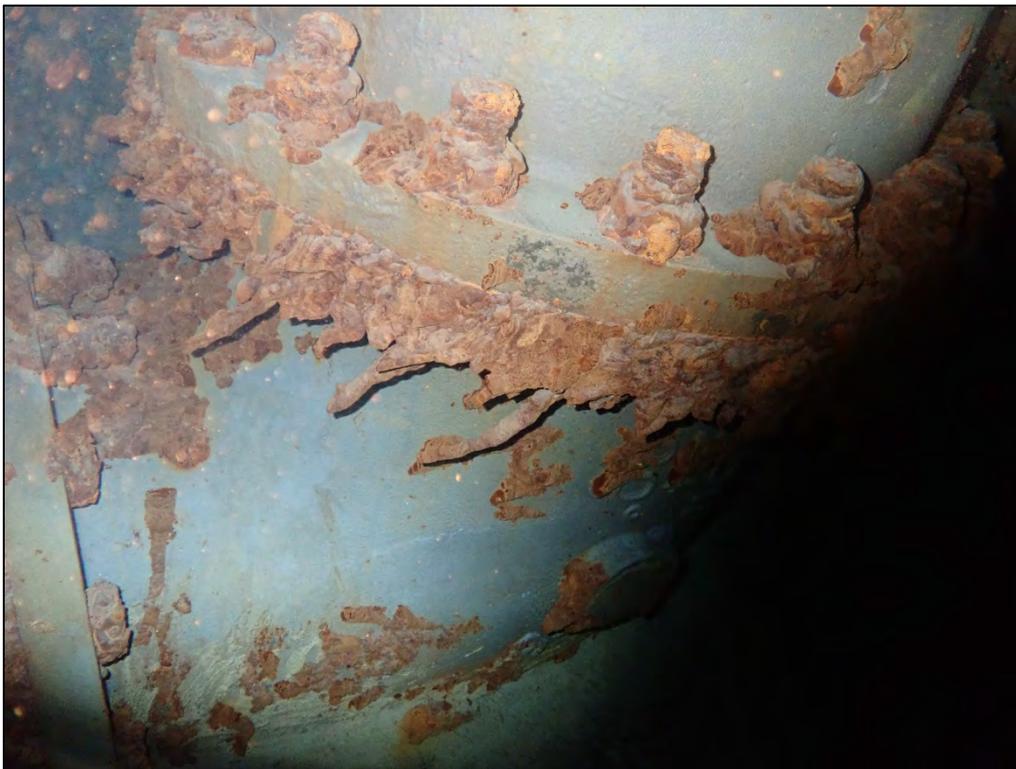
Photograph 8: Typical view of suction pipe.

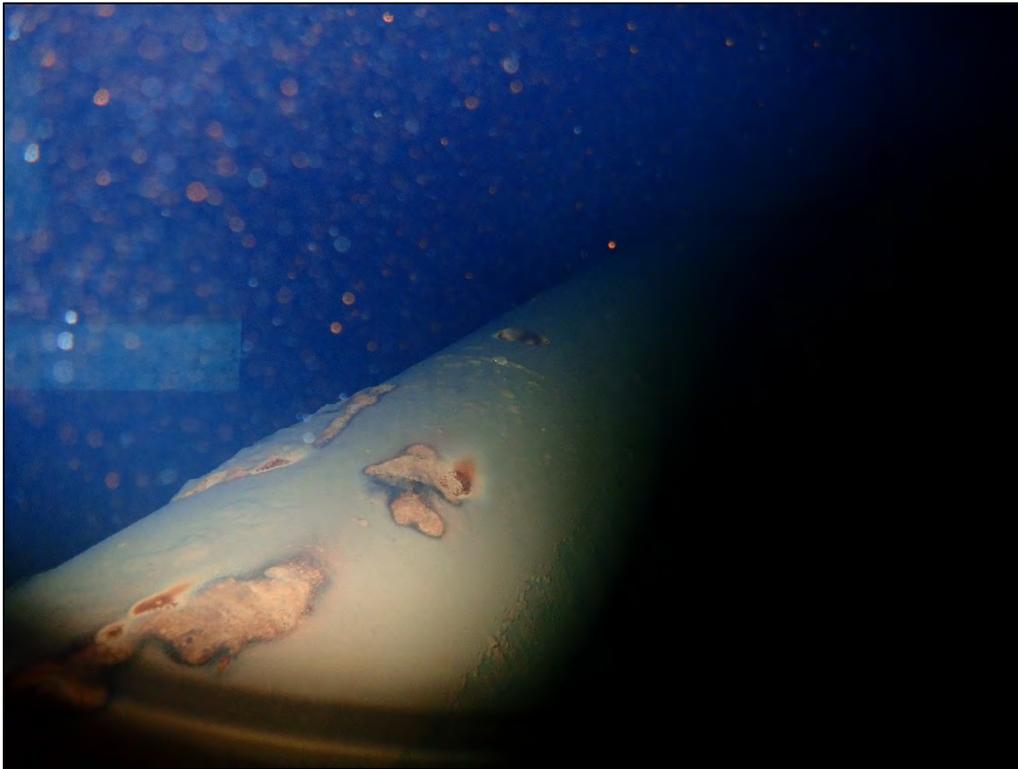
Photograph 9: Typical view of transfer pipe.

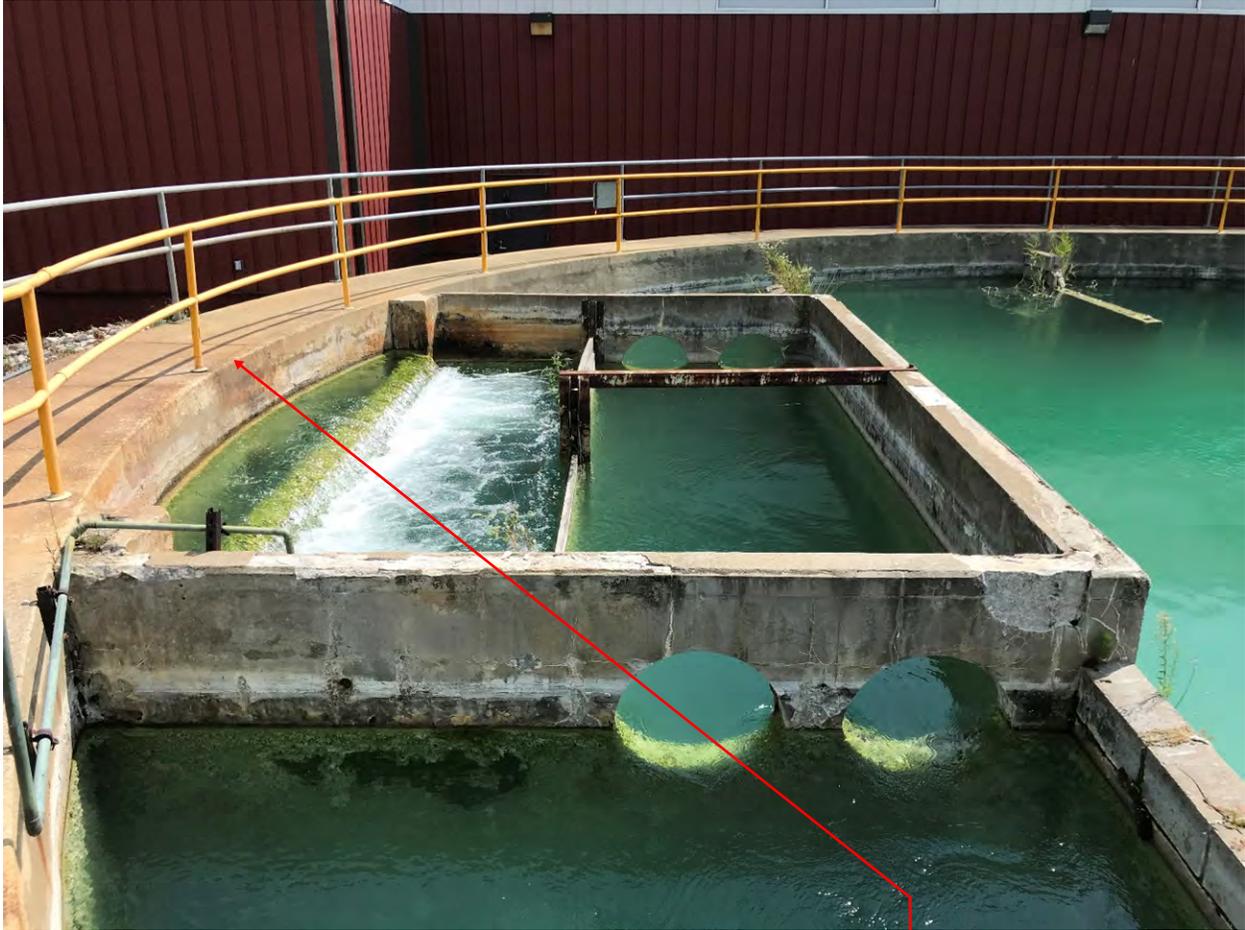
East Recarb Basin Influent Chamber

Reference elevation: 744.11 (East) and 744.10 (West)
Measured WS El: 742.51 (East) and 742.44 (West)
Total Plant Flow: 13 MGD

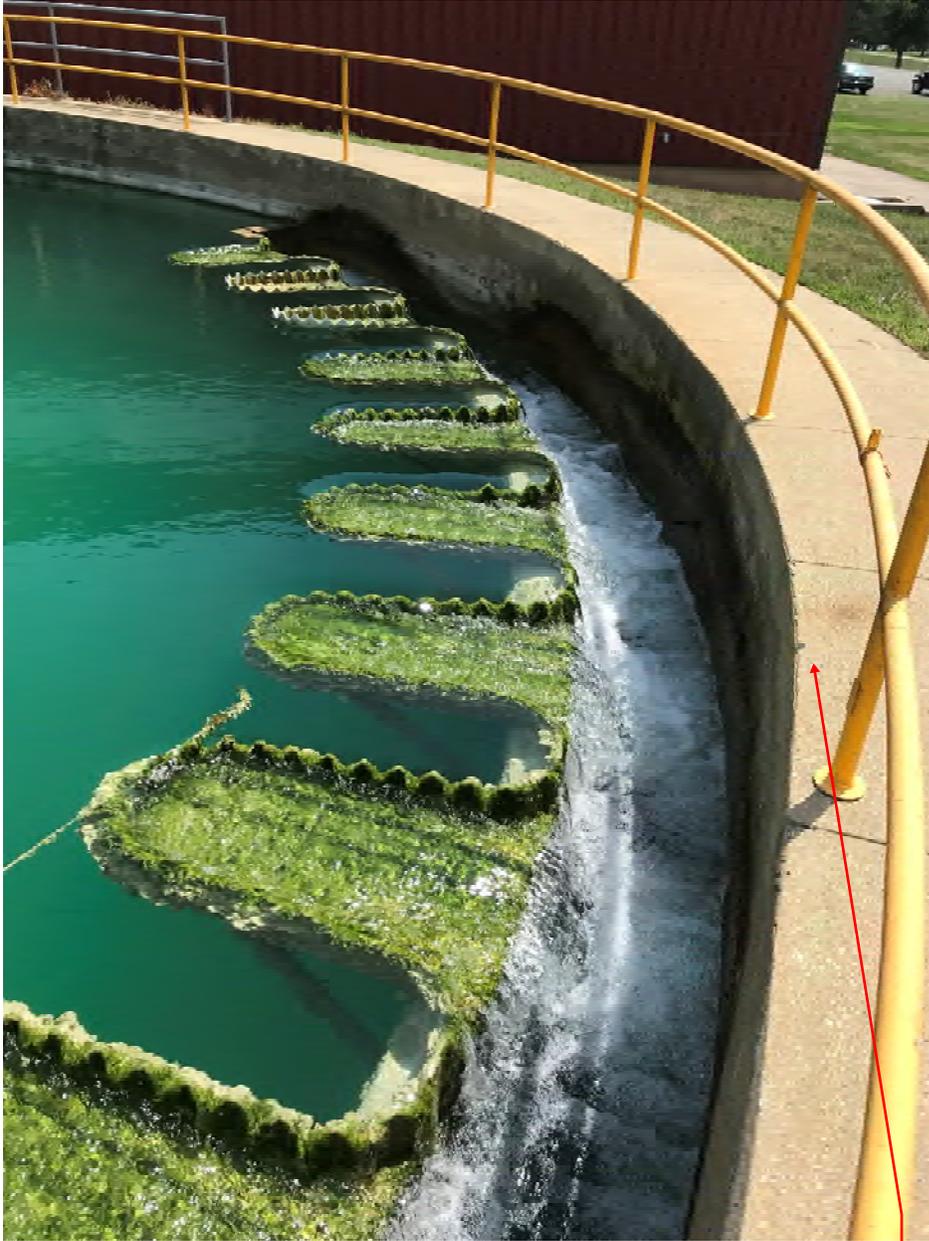
East Recarb Effluent Channel

Reference elevation: 744.11 (East) and 744.10 (West)
Measured WS EI in Basin: 741.83 (East) and 741.86 (West)
Measured WS EI in Effluent Channel: 740.86 (East) and 740.63 (West)
Total Plant Flow: 13 MGD

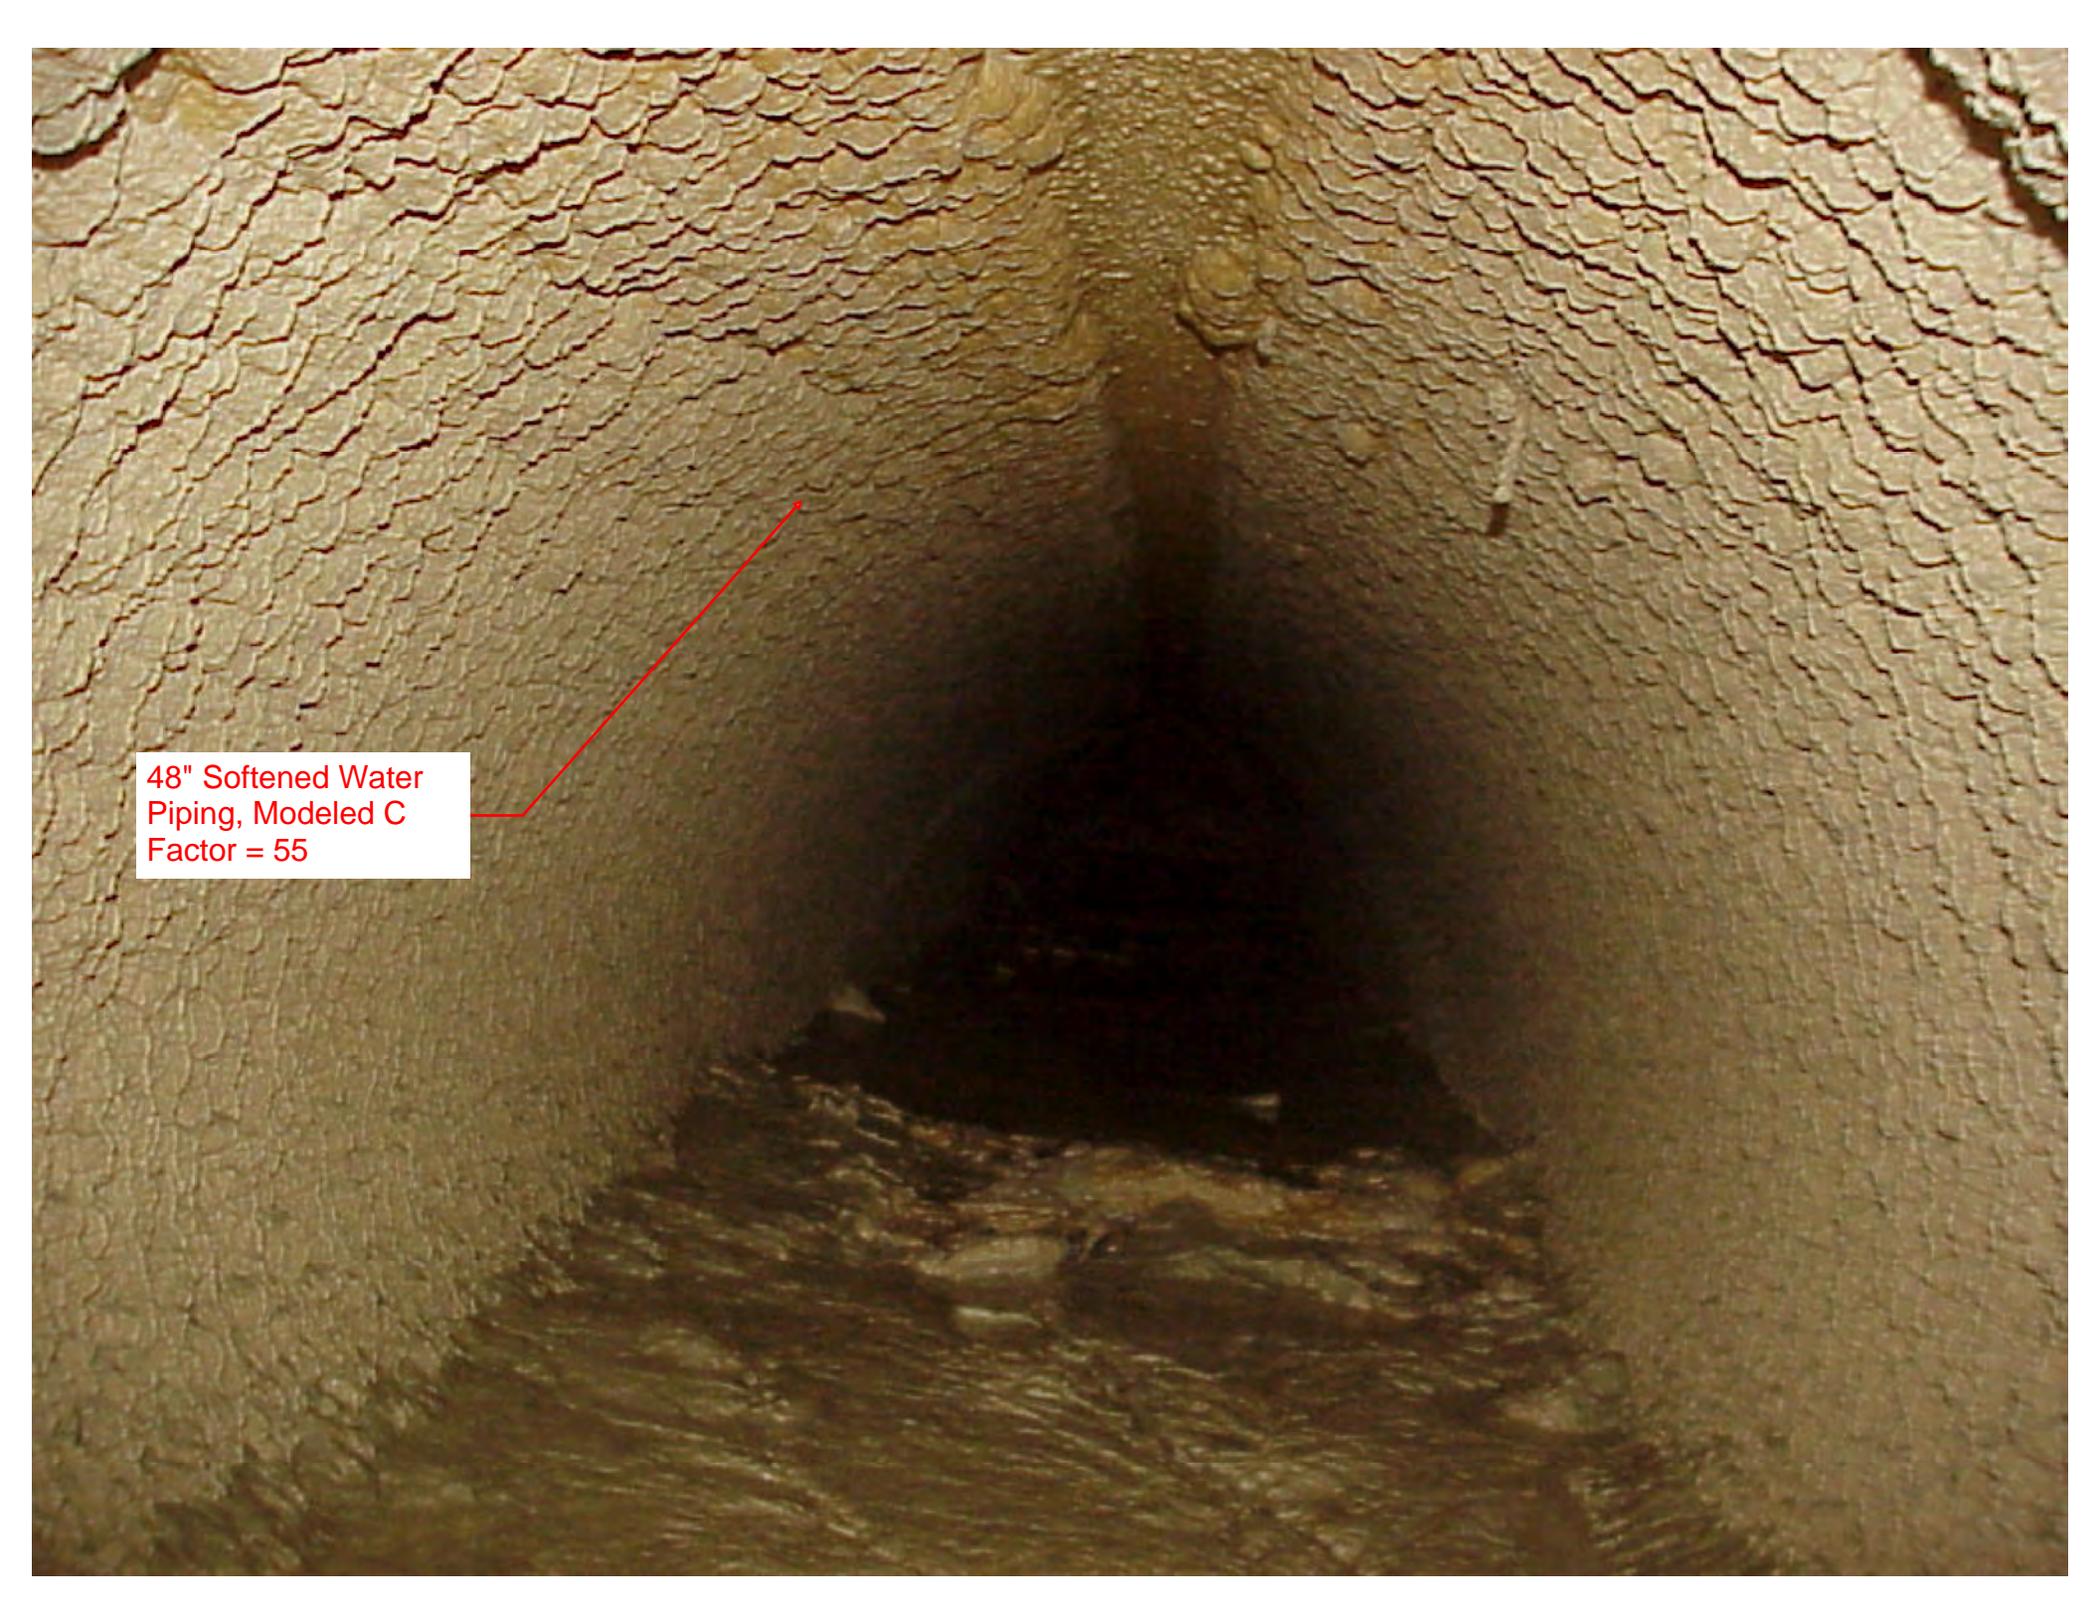
48" Softened Water
Piping, Modeled C
Factor = 55

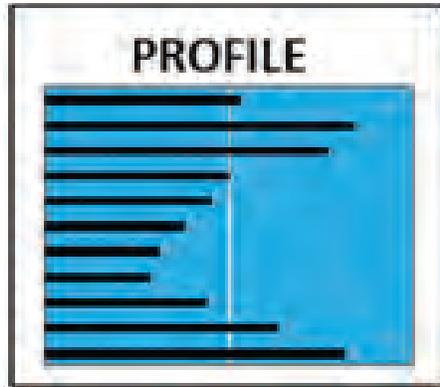
Pumps #1, #2, and #3 were tested while Pump #4 was not due to a malfunction of the motor's soft-starter. Suction head was measured from a single tap on the common manifold for all four pumps. Discharge head was measured from the pressure taps located on the discharge end of each pump. Flow measurements collected from the pitot tap were deemed unreliable, so local flow meter readings were used instead. In addition, there was a leak in an isolation valve on the effluent line that impacted measurements from the local flow meter and pitot tap. Figure 1 shows the velocity profile prepared by M.E. Simpson. The profile does not resemble the parabolic shape expected in a laminar flow condition. Voltage could not be measured, so electrical data was not collected.

Figure 1: Velocity profile of Division Street Pump Station’s effluent line as measured by the pitot rod. The horizontal axis represents the water’s velocity and the vertical axis represents the position in the pipe interior.

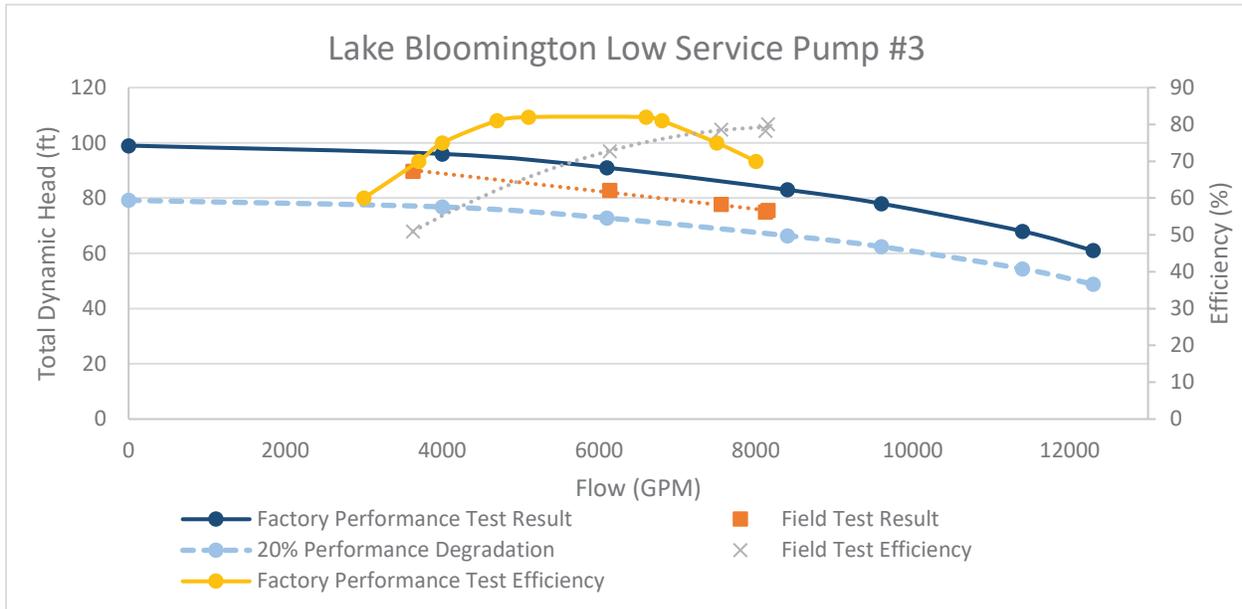
As shown in Figure 3, Pump #3 test results show a greater degradation in performance compared to Pump #1. The TDH has dropped by 6% to 12% from the factory testing results. Lower flow rates of 3,000 gpm to 4,000 gpm experienced a lesser drop in performance than higher flow rates of around 8,000 gpm. However, the test results for Pump #3 are skewed due to the location used for measuring the suction head. There was no available pressure tap directly on the suction end of Pump #3, and the suction head was measured from the Pump #1 suction tap. The test results also show a 20% drop in magnitude of efficiency at low flow rates. The difference in efficiency from the original curve is gradually reduced as the flow rate increases. At around 7,500 gpm, the pump started to operate at an improved efficiency from when it was originally installed. Polynomial regression indicates that the optimal flow rate for Pump #3 is around 8,000 gpm.

Figure 3: Original and updated performance and efficiency curves for Lake Bloomington Low Service Pump #3. Complete results of the factory performance tests are shown in Figure H2-2.

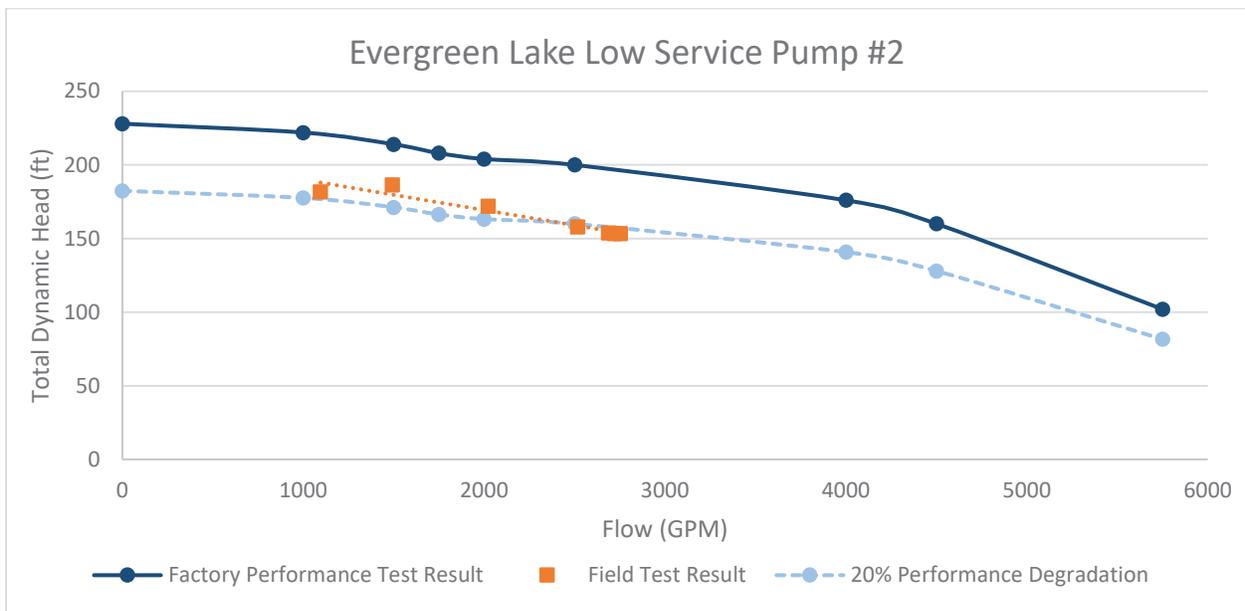
Figures 4, 5, and 6 show the results of the performance tests conducted on the Evergreen Lake Low Service Pumps on February 14, 2018. All three of the Evergreen Lake Low Service pumps were tested. Closing the discharge control valve did not significantly impact flow rate while testing Pumps #1 and #3, causing the data to cluster together. Because the data was clustered together, performance was only measured over a narrow range of flow conditions for Pumps #1 and #3. The change in Pump #1 performance is negligible. Pump #1 performance has slightly improved at flow rates around 1,600 gpm and slightly decreased at higher flow rates around 2,500 to 3,000 gpm since the original test was conducted. On the other hand, the performance of Pumps #2 and #3 shows a larger degradation to around 80% of their factory performance baseline since they were installed. Pump #2's TDH at flow rates around 2,500 gpm has dropped below 80% of the TDH recorded during factory testing.

Figure 5: Original and updated performance curves for Evergreen Lake Low Service Pump #2. Complete results of the factory performance tests are shown in Figure H2-4.

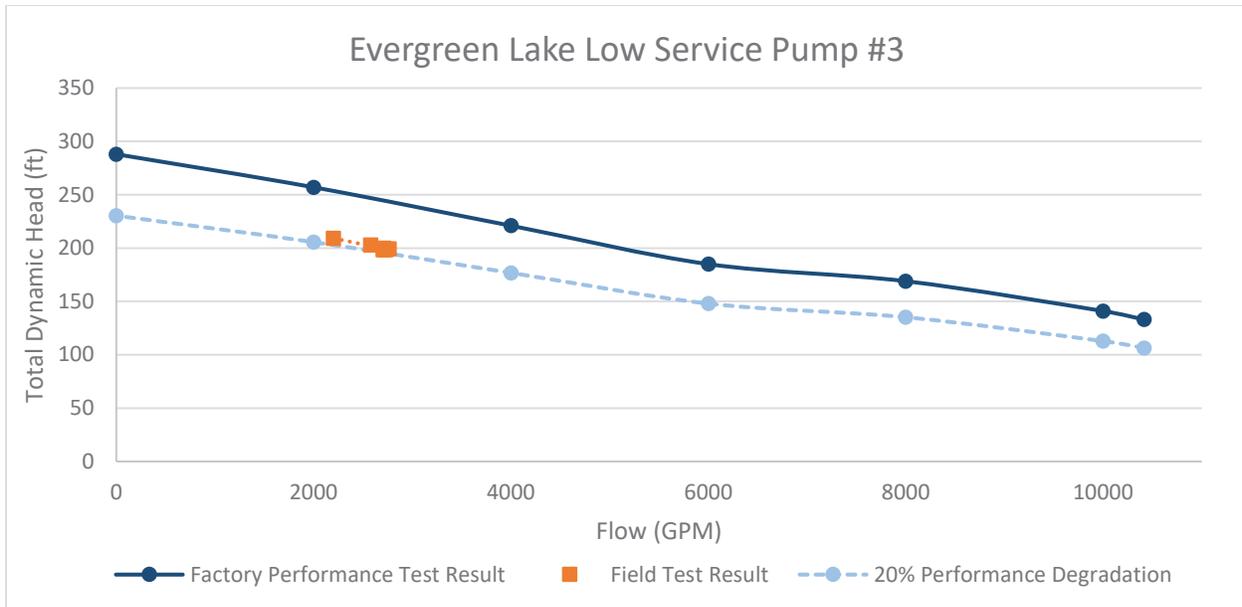
Figure 6: Original and updated performance curves for Evergreen Lake Low Service Pump #3. Complete results of the factory performance tests are shown in Figure H2-5.

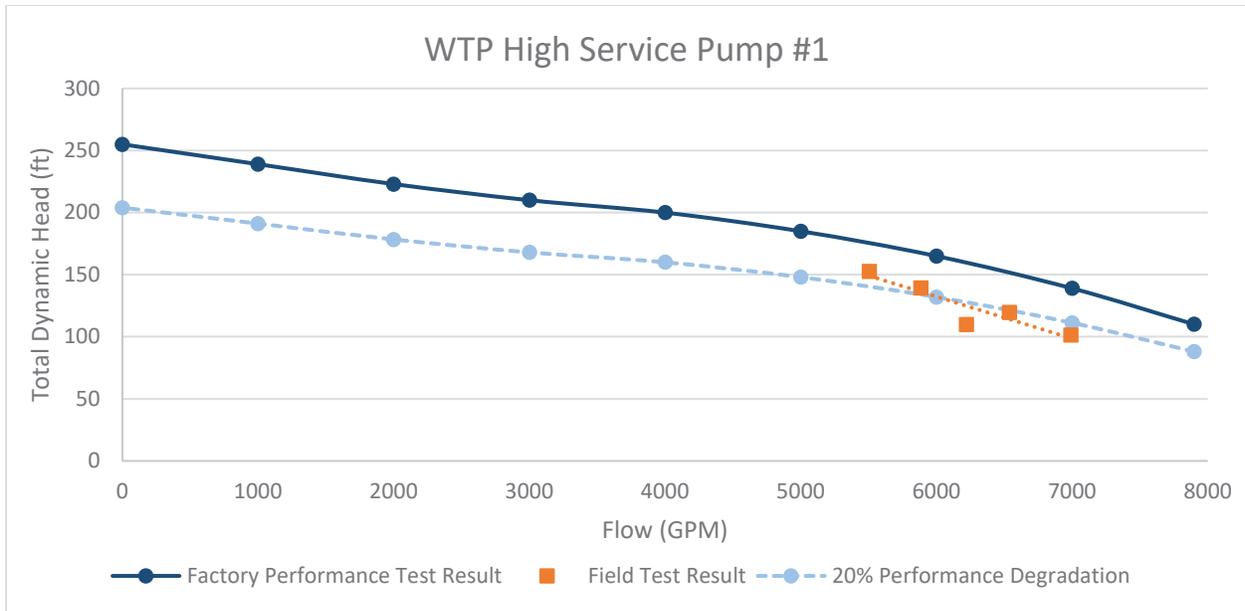
Figures 7, 8, and 9 show the results of the performance tests conducted on the Bloomington WTP High Service pumps on February 8, 2018. All four pumps were tested. Pumps #1 and #2 expressed a similar trend in performance. Their performance is within a 20% margin of the factory performance testing at their lowest tested flow rates. However, as their flow rate is increased, their performance degradation meets or exceeds the 20% threshold. Pumps #3 and #4 have the same factory performance curve and their results are presented together in Figure 9. The results for Pumps #3 and #4 show no decrease in performance and both pumps can reach the same TDH that was achieved during their original factory performance tests.

Figure 7: Original and updated performance curves for WTP High Service Pump #1. Complete results of the factory performance tests are shown in Figure H2-6.

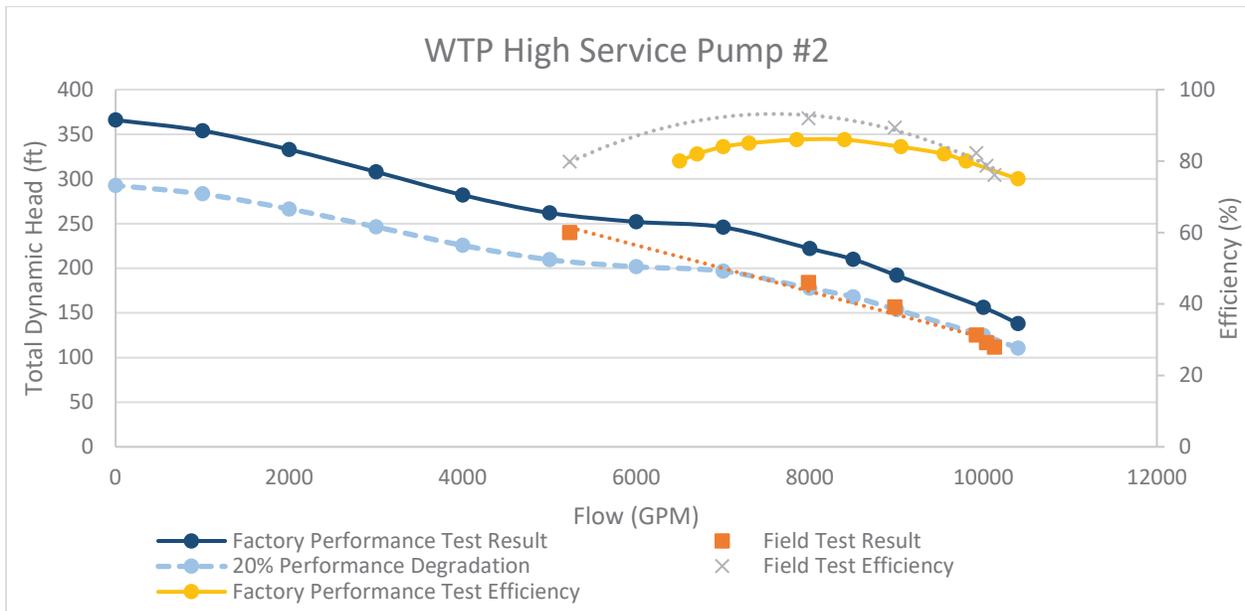
Efficiency was only measured for Pumps #3 and #4. While voltage and current data were collected for Pump #2, the motor efficiency and power factor could not be read off of the motor's nameplate so pumping efficiency could not be calculated. Neither Pump #3 or #4 showed a change in efficiency compared to the original factory performance testing. Polynomial regression of the measured efficiency vs flow rate data shows that the optimal flow rates for Pumps #3 and #4 are 9,800 gpm and 9,500 gpm respectively.

Figure 8: Original and updated performance and efficiency curves for WTP High Service Pump #2. Complete results of the factory performance tests are shown in Figure H2-7.

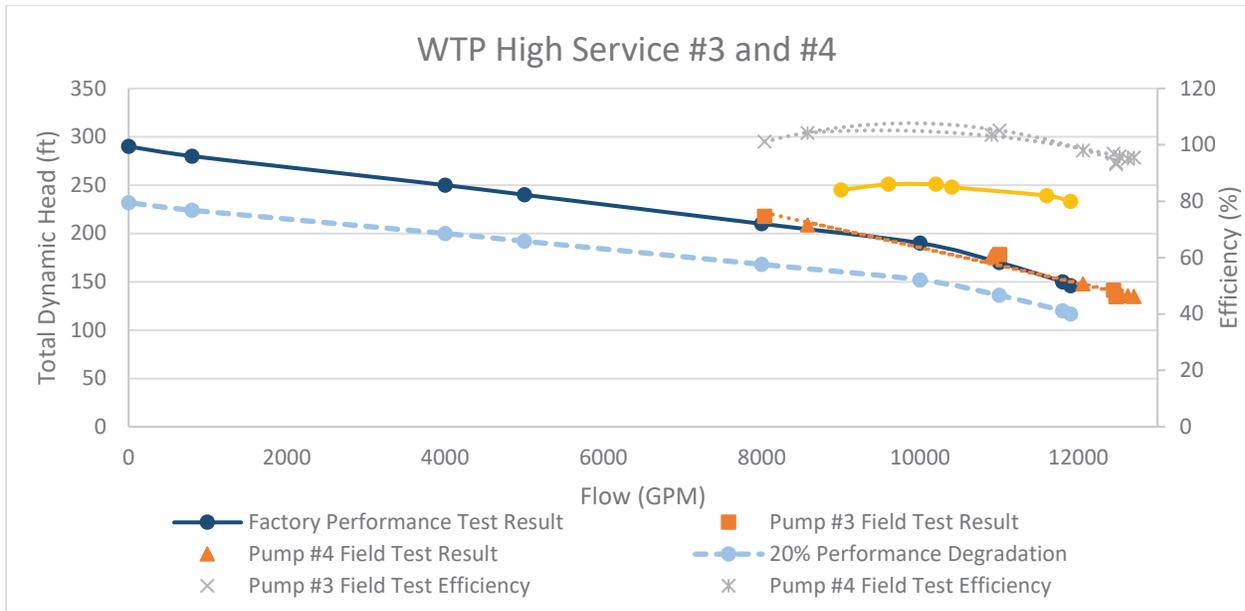
Figure 9: Original and updated performance and efficiency curves for WTP High Service Pump #3. Complete results of the factory performance tests are shown in Figure H2-8. Note: Power factor or voltage readings appear to be off based on efficiencies higher than 90%.

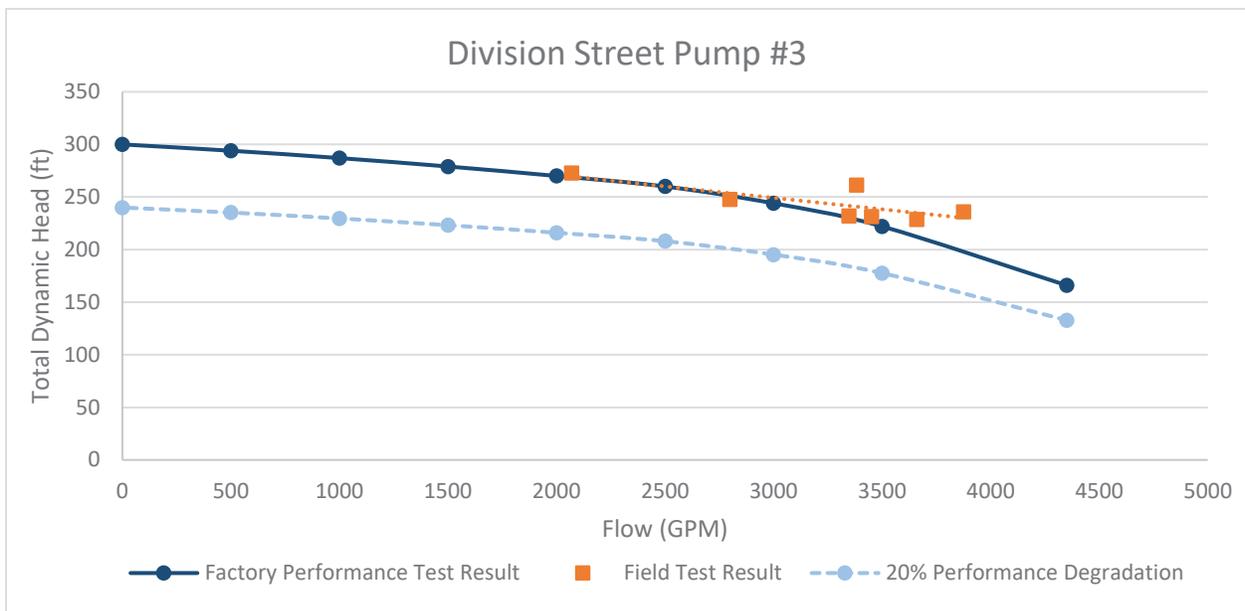
Figures 10 and 11 show the results of the performance tests conducted at the Division Street Pump Station on February 12, 2018. Only Pump #1, #2, and #3 were tested because there were mechanical issues in turning on Pump #4. In addition, the pitot data collected while testing Pump #1, #2, and #3 yielded an uneven velocity profile. The velocity profile indicated a turbulent flow condition at the location of the pitot rod, which could have been caused by a partially closed valve upstream of the pitot tap. As a result, the pitot data was deemed unreliable so the flow readings from the local flow meter were used in its place. The local flow meter's accuracy is unknown. Pumps #1 and #2 have the same factory performance curve and their results are presented together in Figure 10. Pumps #1 and #2 performance has degraded by around 5% to 10% since their original factory test. Pump #1 performance has been reduced the most at flow rates between approximately 1,300 gpm and 2,000 gpm, while Pump #2 experienced the largest reduction in performance at flow rates between 800 gpm and 1,800 gpm. Pump #3 exhibited no performance degradation. None of the data points for any pump show a performance decrease greater than 20%.

Figure 11: Original and updated performance curves for Division Street Pump Station Pump #3. Complete results of the factory performance tests are shown in Figure H2-10.

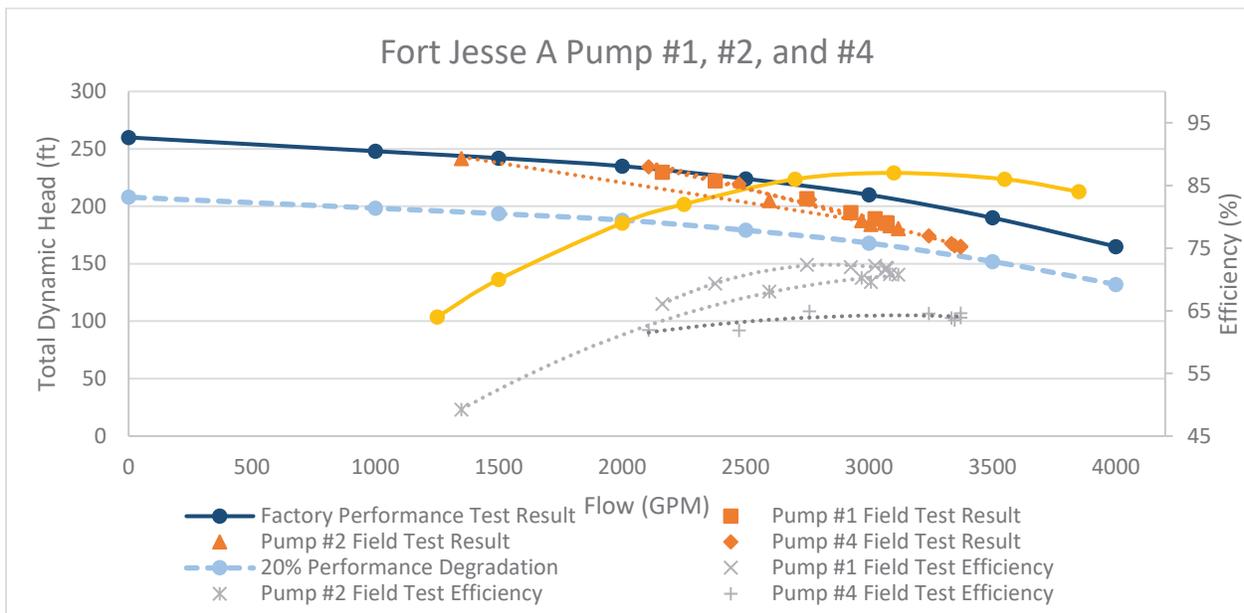
Figure 12 shows the results of the performance tests conducted at the Fort Jesse A Pump Station on February 7, 2018. Only Pumps #1, #2, and #4 were tested. Pumps #1, #2, and #4 have the same factory performance curve so their results are presented together in Figure 12. The three pumps follow a similar trend – there is minimal change in performance from the original factory test at flow rates between 1,400 gpm and 2,500 gpm, while there is a 5% to 10% drop in performance beyond 2,500 gpm.

Each pump also exhibited a large drop in efficiency in the range of flow rates tested. The efficiency of each pump is approximately 15% to 25% lower than the factory performance efficiency. Polynomial regression of the updated efficiency results estimate the optimal flow rate for Pumps #1, #2, and #4 to be 2,900 gpm, 3,300 gpm, and 3,100 gpm respectively.

Figure 12: Original and updated performance and efficiency curves for Fort Jesse A Pump Station Pump #1. Complete results of the factory performance tests are shown in Figure H2-11.

While pump efficiency could not be calculated for all pumps, the efficiency results available show a general decline from the factory testing results. The three pumps tested in the Fort Jesse A Pump Station have experienced the largest decline in efficiency of all pumps tested. Operating the pumps at their maximum efficiency should be incorporated to reduce energy usage. CDM Smith recommends investigation and maintenance on the Fort Jesse A and B pumps to evaluate and address the loss of efficiency for those pumps.

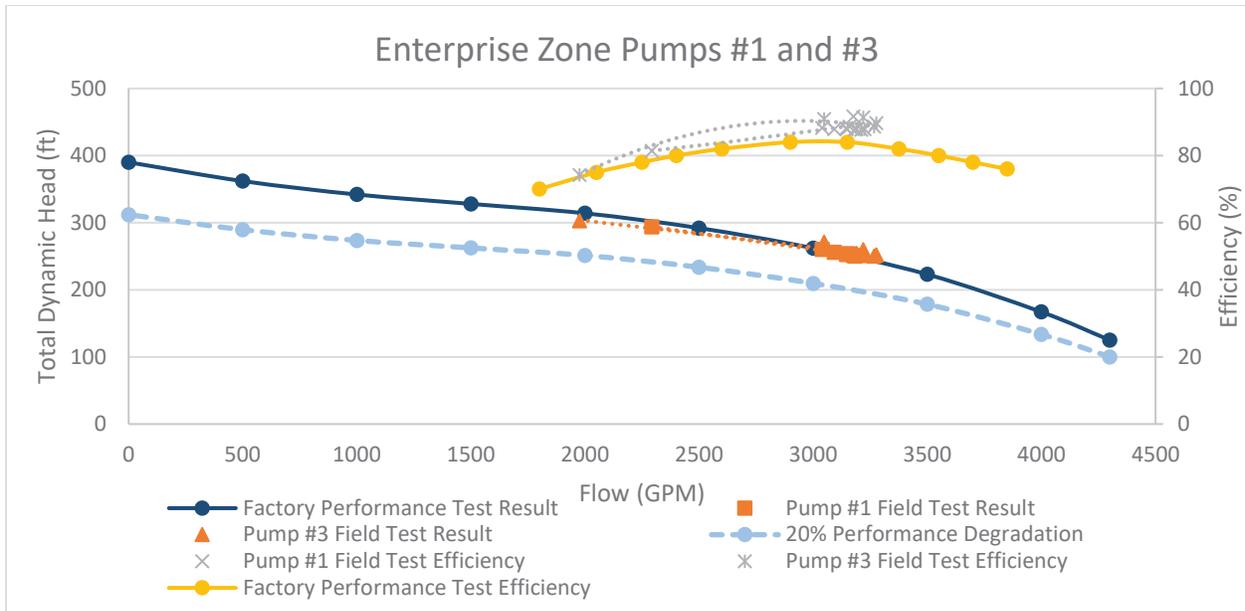
Figure 14 shows the results of the performance testing conducted at the Enterprise Zone Pump Station on February 13, 2018. While all three pumps were tested, only Pump #1 and #3 data are presented as there were difficulties measuring the flow rate of Pump #2. Pumps #1 and #3 have the same factory performance curve so their results are presented together in Figure 14. Both Pumps #1 and #3 have experienced very little degradation in performance as their TDH is within 5% of the original factory test. However, due to clustering of data at the higher flow rates tested, there are essentially only two data points. Closing the discharge control valve had very little impact on the flow rate when it was between 100% to 16% open. A significantly different flow rate was not measured until the discharge control valve was only 5% open. Ideally, closing the discharge control valve would have resulted in a larger spread of tested flow rates to get a more complete picture of the pump’s performance capabilities.

Efficiencies of Pumps #1 and #3 have not changed since the pumps were first installed. Due to clustering of data, polynomial regression cannot be effectively used to estimate the optimal flow rate in terms of efficiency. From looking at the test results, the efficiency for Pumps #1 and #3 appears to be greatest at around 3,100 gpm and 3,000 gpm respectively.

Figure 14: Original and updated performance and efficiency curves for Enterprise Zone Pump Station Pump #1. Complete results of the factory performance tests are shown in Figure H2-13.

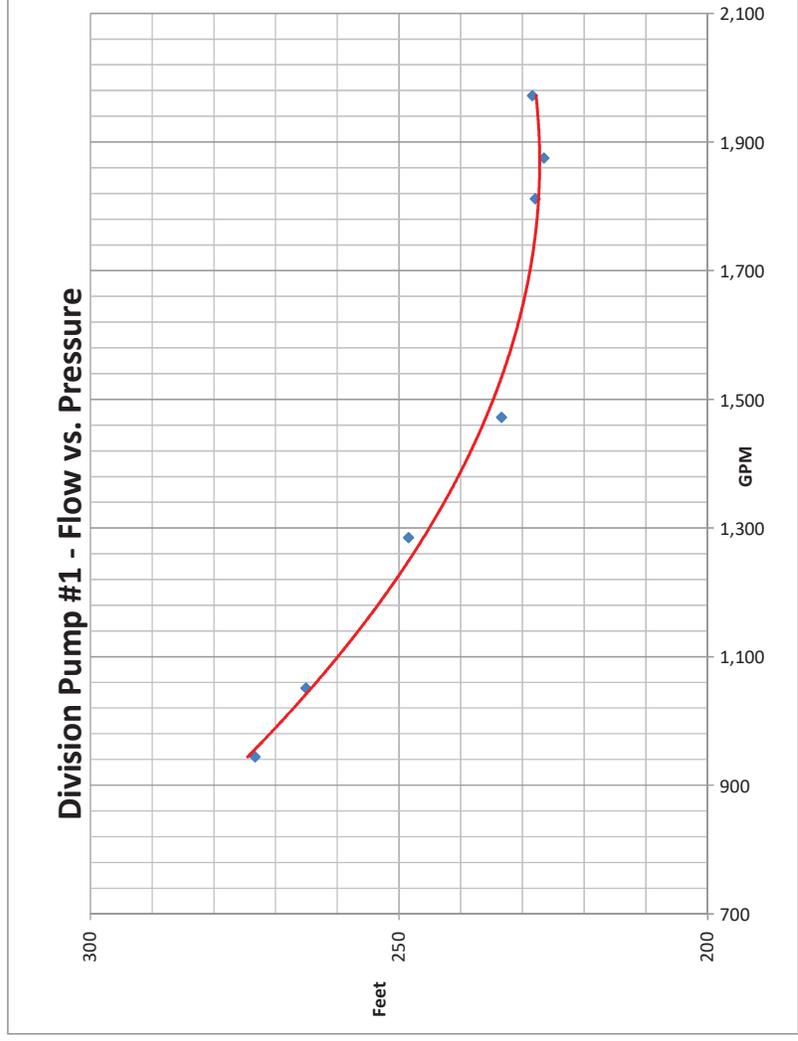
The Pitot test tap is not reliable. The velocity profile was "inverted" and the flow data is not usable. Local meter readings were used for this pump curve. The accuracy of the local meter is not known and it may be malfunctioning.

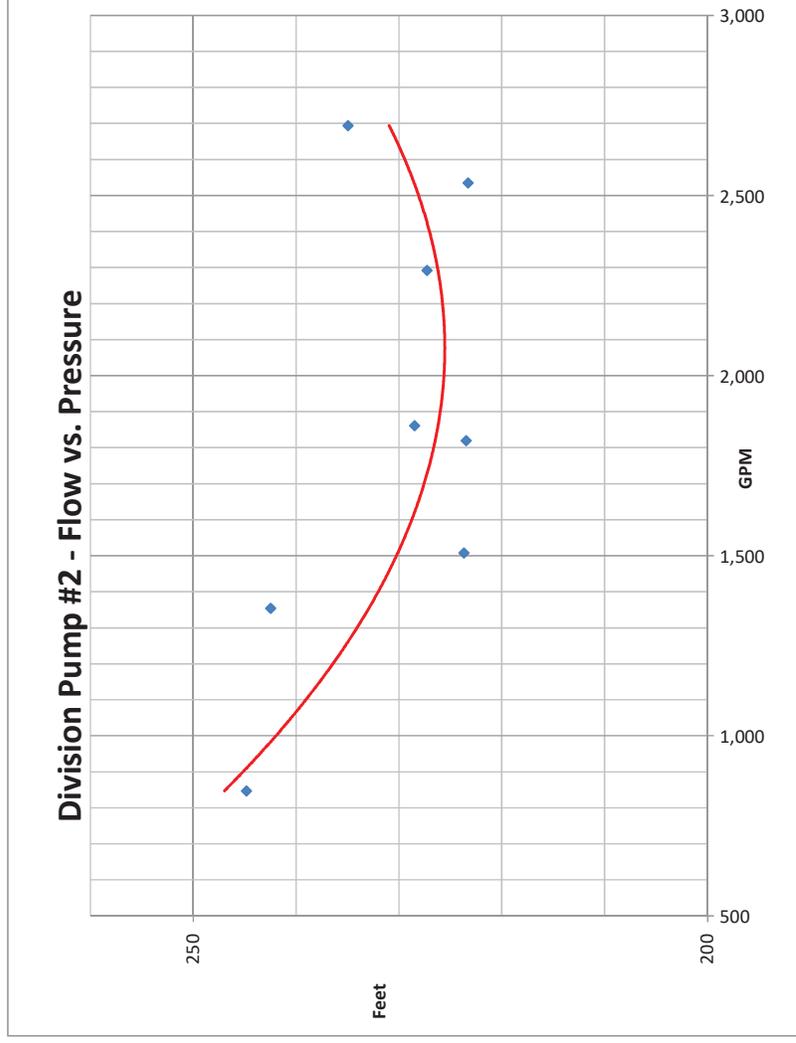
Division - Pump #2

The Pitot test tap is not reliable. The velocity profile was "inverted" and the flow data is not usable. Local meter readings were used for this pump curve. The accuracy of the local meter is not known and it may be malfunctioning.

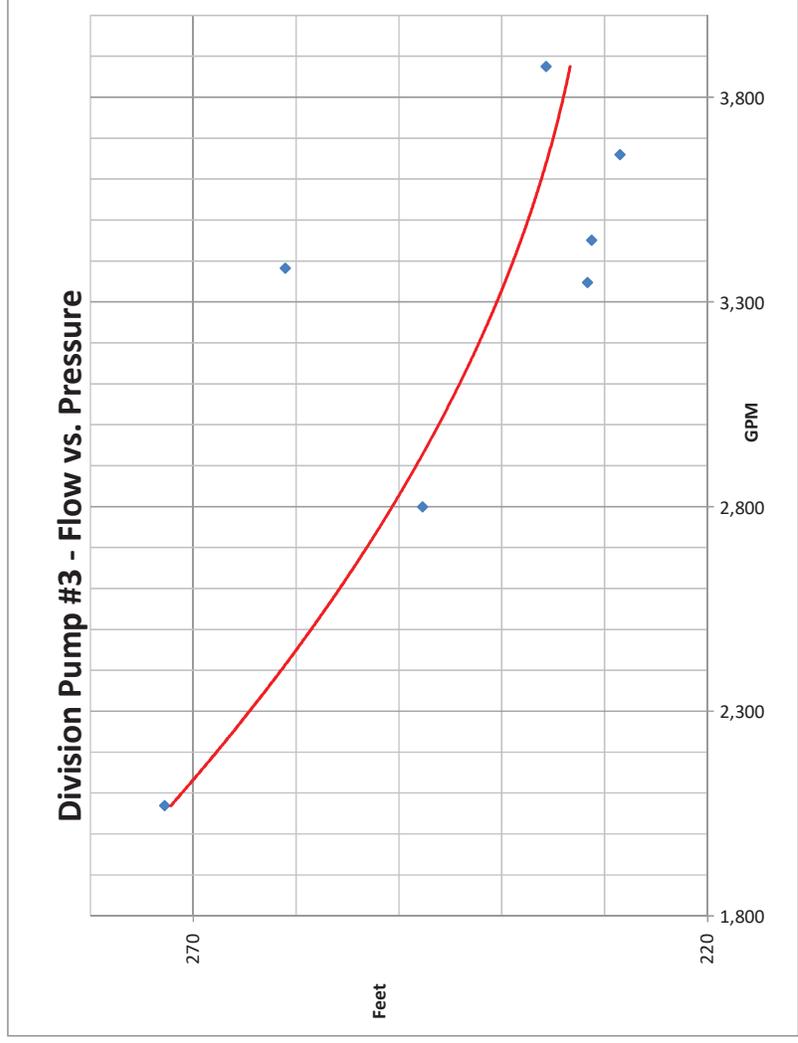
Division - Pump #3

The Pitot test tap is not reliable. The velocity profile was "inverted" and the flow data is not usable. Local meter readings were used for this pump curve. The accuracy of the local meter is not known and it may be malfunctioning.
