REPORT

**Water Infrastructure
Master Plan**

City of Bloomington, IL

November 2019

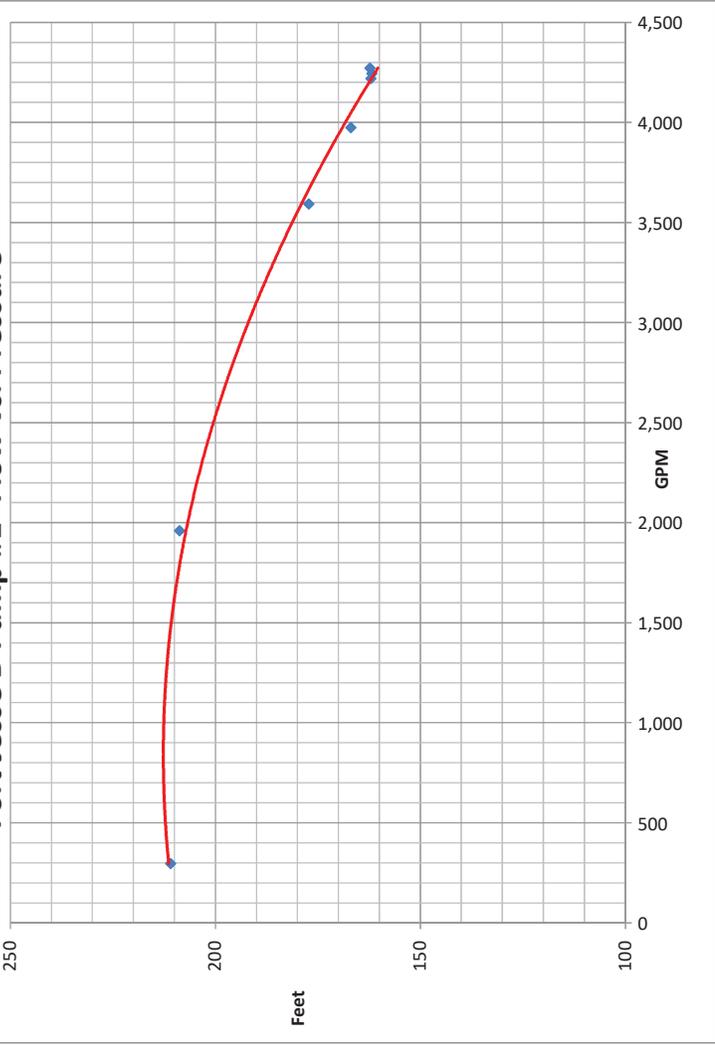
Fort Jesse B Pump #1- Flow vs. Pressure

Figure 13 shows the results of the performance tests conducted at the Fort Jesse B Pump Station on February 15, 2018. All three pumps at Fort Jesse B were tested. Pumps #1, #2, and #3 have the same factory performance curve so their results are presented together in Figure 13. Each of the pumps has experienced significant degradation in performance when compared to the factory performance curve and follow a similar trend of reduced TDH as flow increases. For example, the TDH is approximately 5% to 10% lower than it was in the factory performance test at flow rates between 300 gpm and 2,000 gpm. As the flow rate increases to 4,000 gpm, there is almost a 20% drop in TDH from the factory performance test.
